Structural analysis of the eroded CFC tiles of Tore Supra: Insights on ion transport and erosion parameters

Deuterium Inventory in Tore Supra

This Study

Post mortem SEM, TEM, AFM, Raman analyses of the top surface of eroded TS tiles

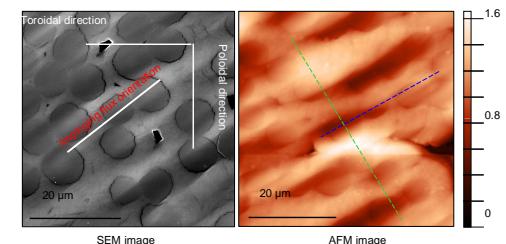
Ripple patterning of the tile surface

SEM/AFM analysis on eroded tile

- Formation of a ripple pattern
- dynamic balance among fundamental surface processes (erosion of fibre/matrix, ion-induced defect creation)
- And defect-mediated evolution of the surface morphology
- \Leftrightarrow Impinging flux projection \perp to wave vector

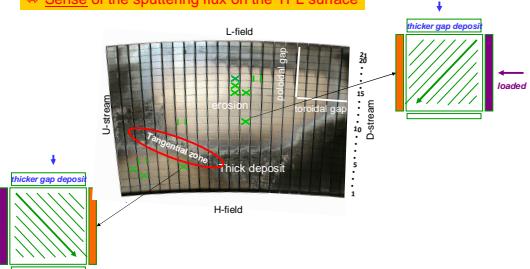
Sense of the sputtering flux on the TPL surface

Direction of the sputtering flux on the TPL surface

- Formation of a sawtooth profile
 - shadowing effect due to 2 different erosion rates
 - Impinging flux projection is directive
