Introduction: The ITER divertor system aims to exhaust a significant part of the plasma power and to minimize the helium and impurity content in the plasma. The Inner Vertical Target (IVT), to be delivered by European domestic agency, is constituted of Carbon Fibre Composite (CFC) monoblocks in the lower part and tungsten (W) monoblocks in the upper part. The CFC armour material must have some technical and non-technical requirements. CFC must have high mechanical and thermal properties fitting to the PFC manufacturing process (joining CFC to a CuCrZr tube) and to the inspection requirements (detecting defect at CFC to CuCrZr interface). Moreover, PFC and CFC must be adapted to the in service needs. The objective of the paper is to report on PFC made with different techniques and with different CFC grades (N31, NB31, N11, NB41, DMS814, DMS780, Dunlop 3D and SGL sigrabond) about their inspection after manufacturing and about their thermal behavior under thermal loads.

Evaluation of component quality after manufacturing with SATIR, CEA

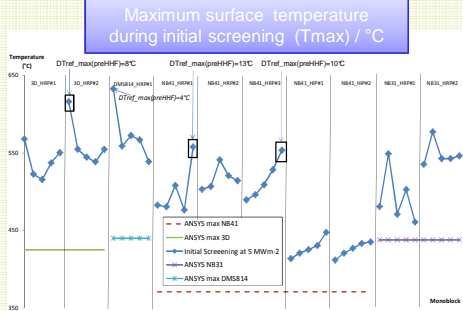
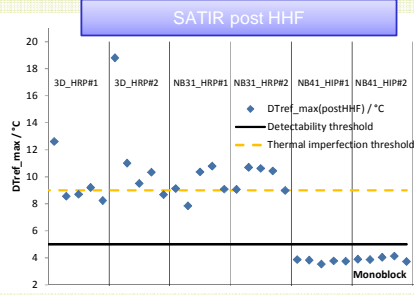
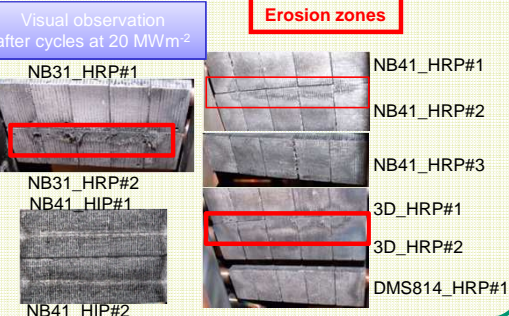
- Overall good quality of all components
- Consistent with SATIR results
 - Tmax: 3D_HRP > NB41_HRP > NB41_HIP
 - 3 monoblocks emerge (DTref_max=8°C, 13°C, 10°C)
 - Tmax: NB31_HRP#2 > NB31_HRP#1

- Good quality of NB41_HIP
- 3D_HRP and NB31_HRP underwent thermal degradation in terms of heat transfer capability
- Erosion is visually less important for NB41_HIP than for other HHF tested components
- Erosion is due to sublimation which may be explained with an higher temperature during thermal loads (defect and/or thermal conductivity degradation)
