Neutron tomography as a new method for 3D structure analysis of CFC as plasma facing material

B. Schillinger, H. Greuner, Ch. Linsmeier

Aim: Investigation of Carbon Fibre Composite (CFC) morphology modifications of highly heat loaded divertor components after cyclic heat load experiments.

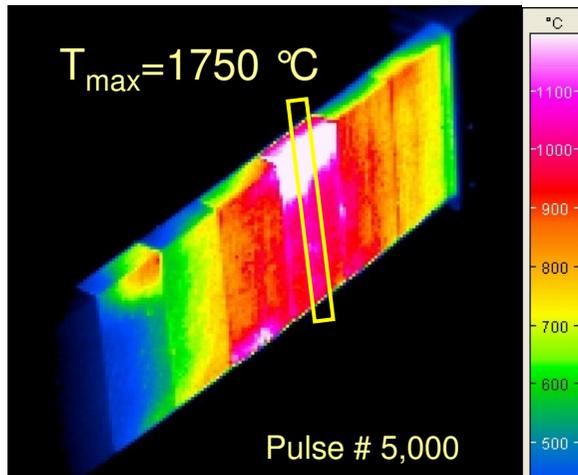
IR image of pulse 5,000

Metallographic investigation:
large delamination of ~14 mm
length, in agreement with FEM
calculation

Spatial structure of the crack or of
the CFC structure after loading?

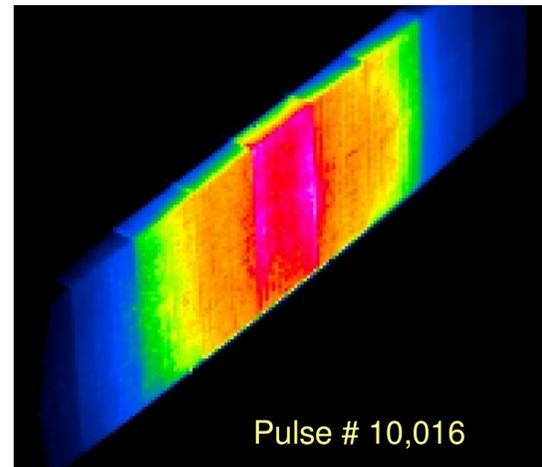
IR image of pulse 10,000

Surface temperature
increased from initially
1085 °C to 1125 °C
Cooling structure
temperature constant.

Reason: slight CFC or
bonding degradation?

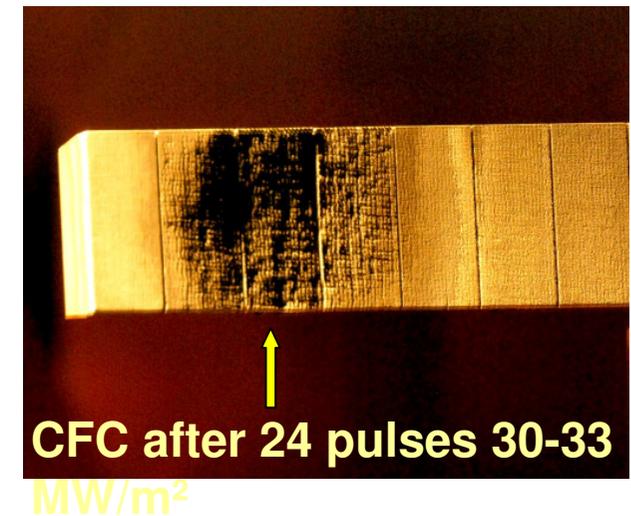
CCD image after overloading

Surface temperature
exceeded 2200 °C
Strong carbon evaporation

Structure of remaining
CFC?

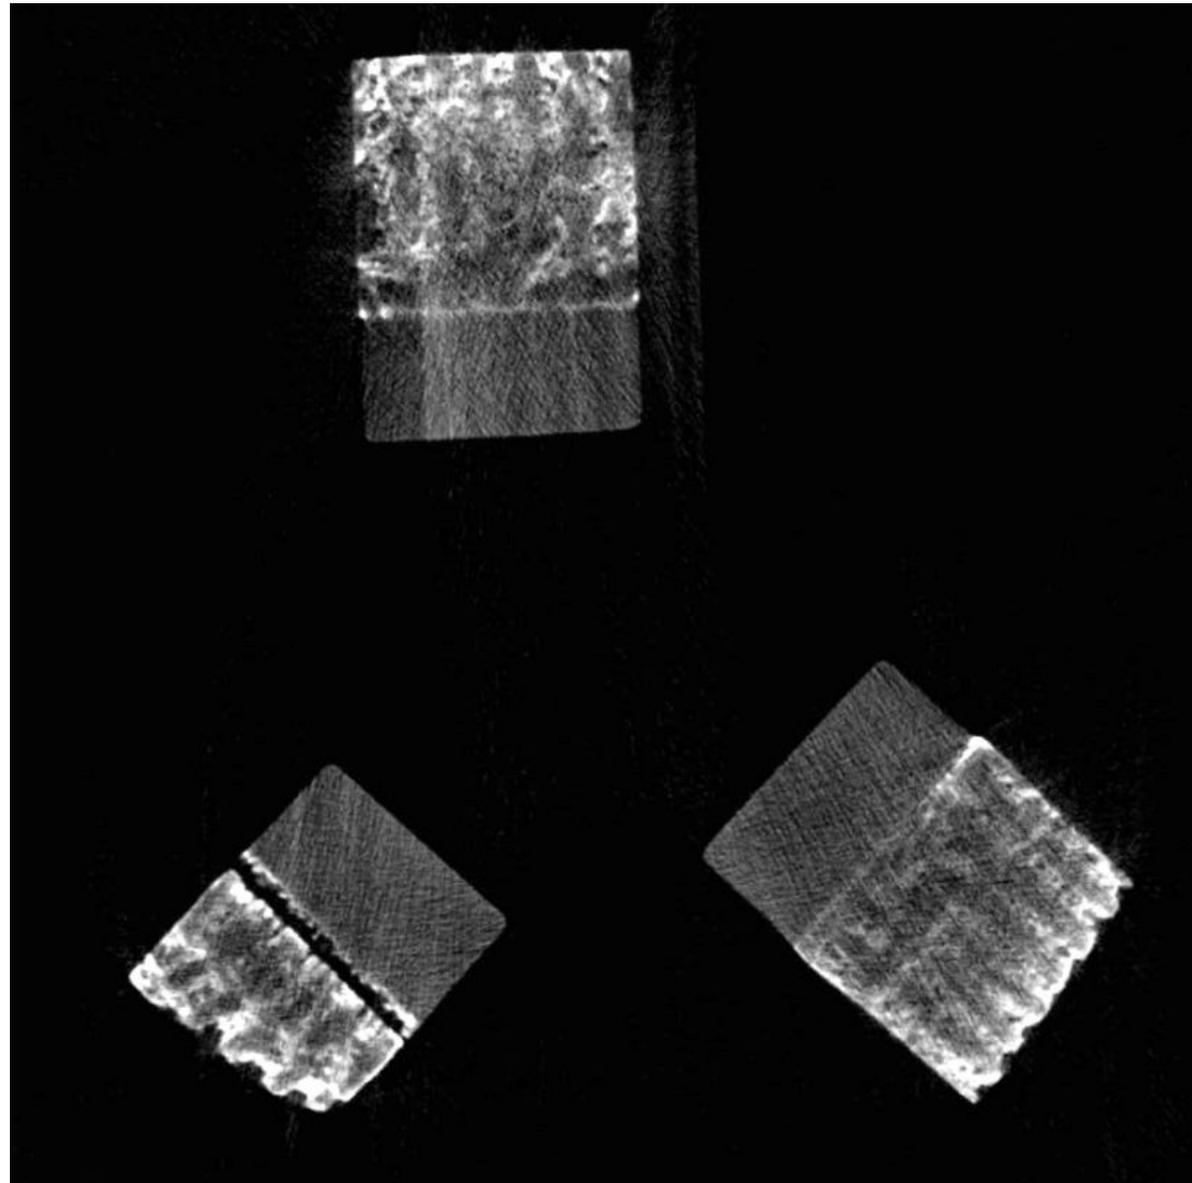
One reconstructed tomographic slice at 45 mm height of above the rotation table.

**S 32 (bottom left),
S 10 (top center),
S 32-2 (bottom right).**

Copper appears grey, bright parts are gadolinium contrast agent.

The large crack is not filled.

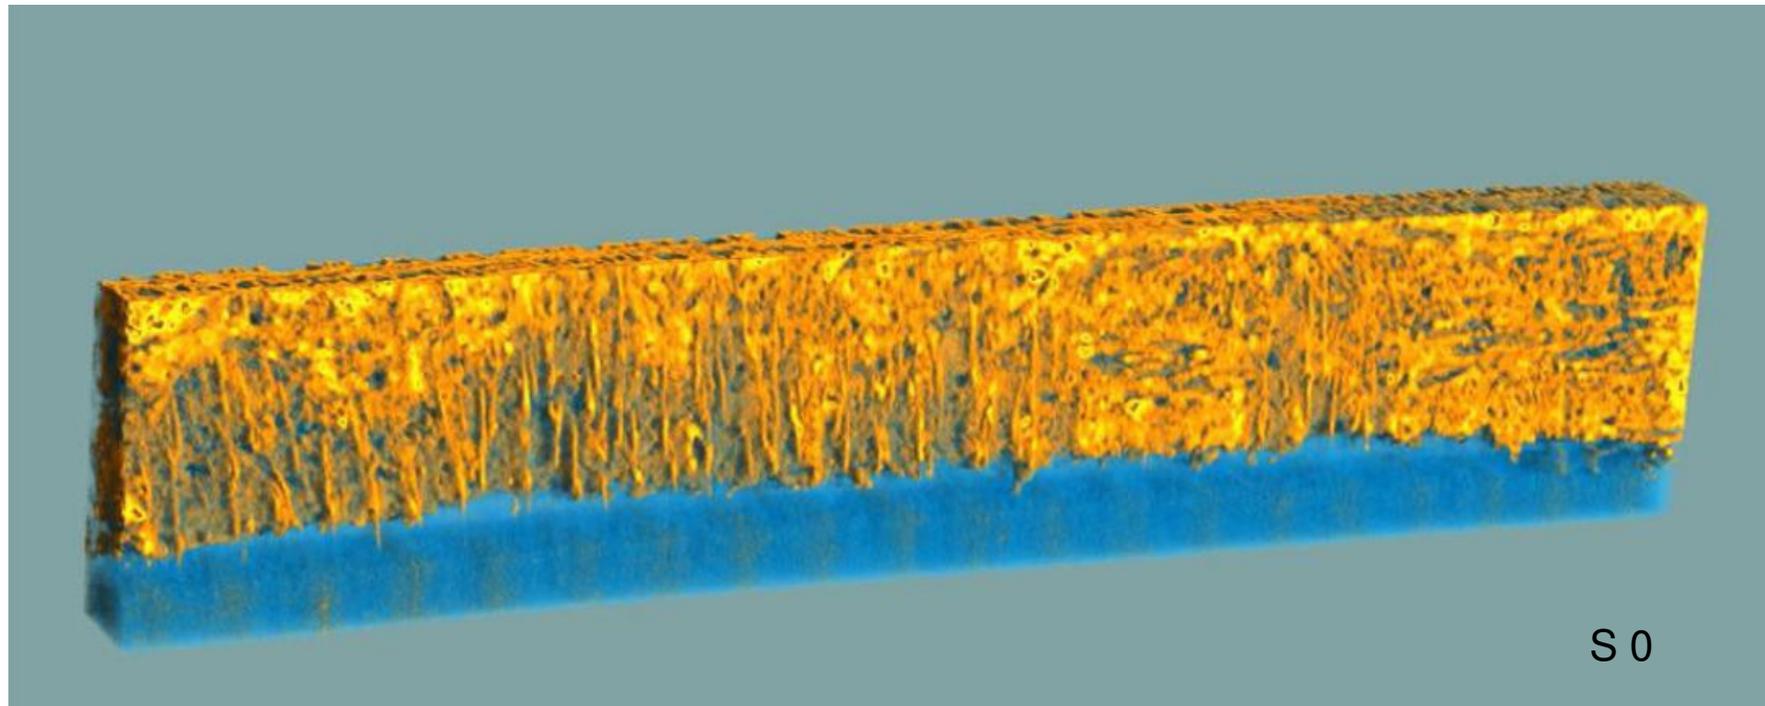
**The viewing area crosses two CFC fibre planes.
The perpendicular oriented ex-pitch fibre bundles are visible in the left part,
the parallel oriented ex-PAN fibrous webs are visible in the right part.
The initial CFC/Cu interface forms a barrier against the infiltration of Gd.
Only a few isolated pores in the AMC layer could be revealed.**

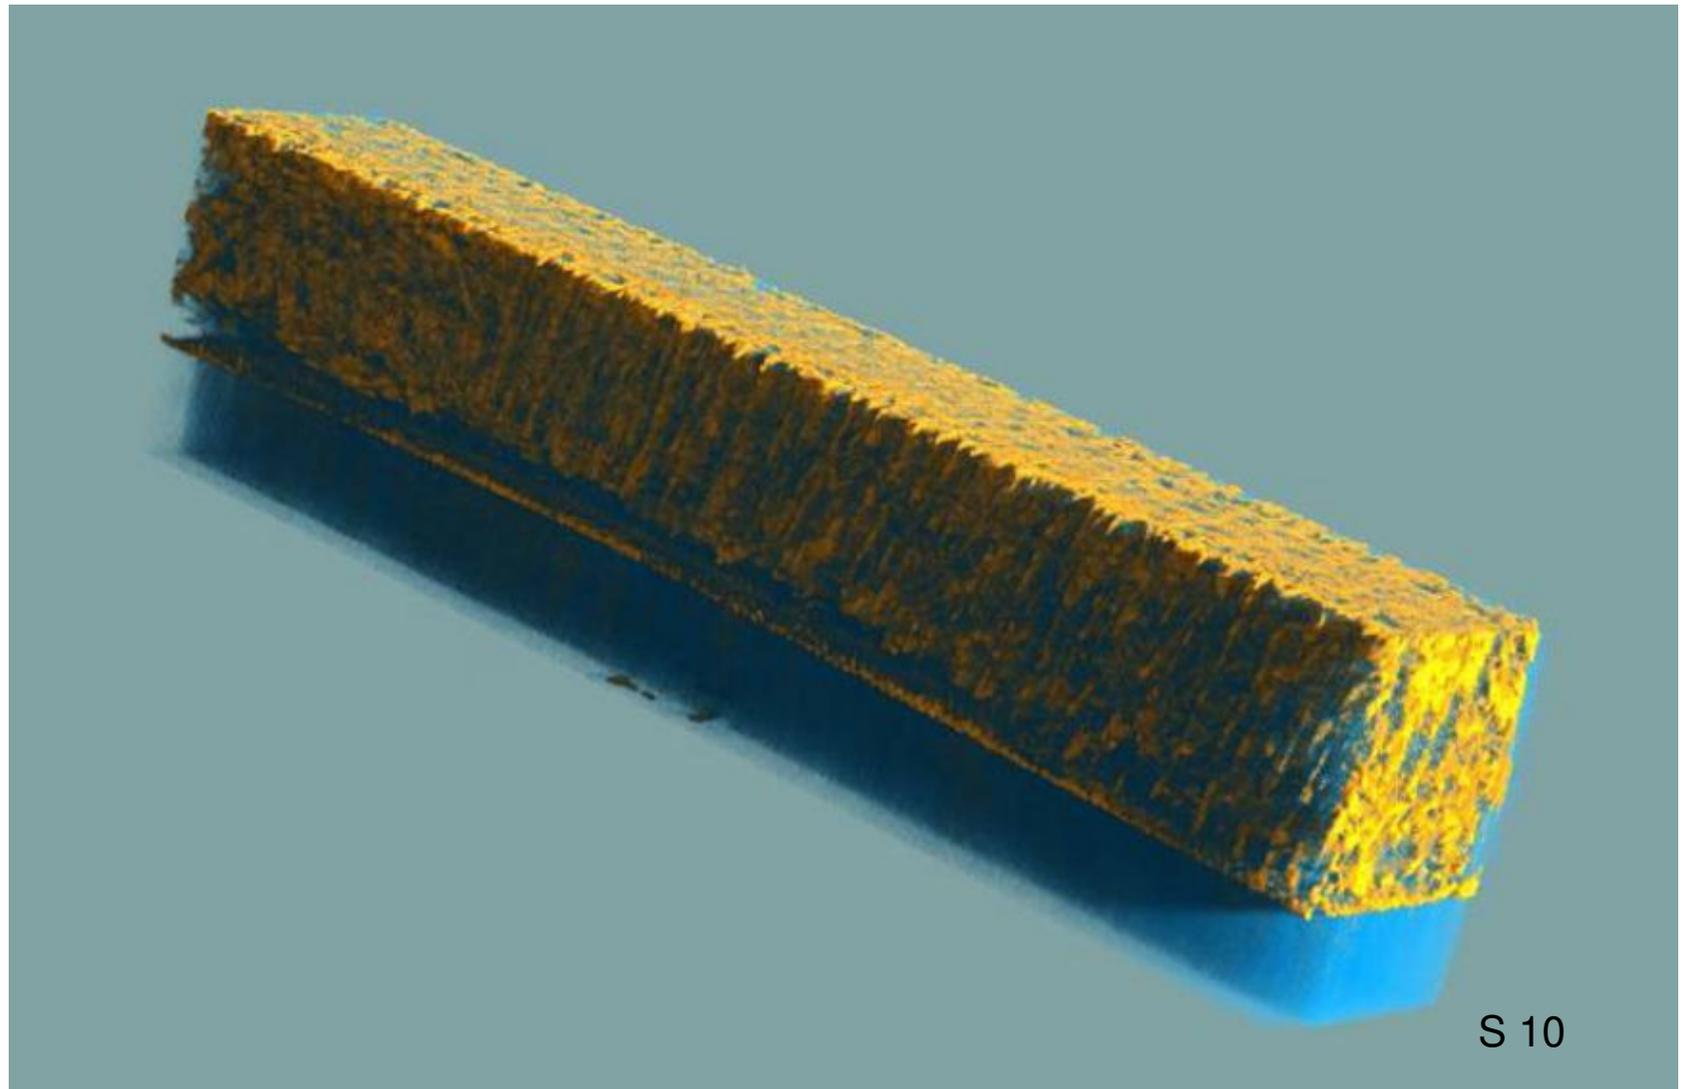
**Image of S 10
after 10,000
cycles 10
MW/m².**

**The micro-
fissures in
the CFC/Cu
interlayer are
visibly filled
with contrast
agent.**

- **No degradation** of the CFC structure after the 10,000 cycles observed.
- No indication of a growing delamination between the different types of carbon fibres and the matrix, both for the ex-pitch, and for the ex-PAN fibres.
- **Micro-fissures** are visible in the CFC/Cu interlayer. This is the cause of the measured surface temperature increase.
- **The heat transfer capability is slightly reduced, but the laser structured CFC surface prevents crack propagation and the formation of large failures.**
- As result, **no sudden loss of tiles expected.**
- No irregularities revealed in the AMC/Cu bonding of the investigated samples after the extended HHF load cycles. No cracks could be identified which would give rise to an increased failure probability of the component.

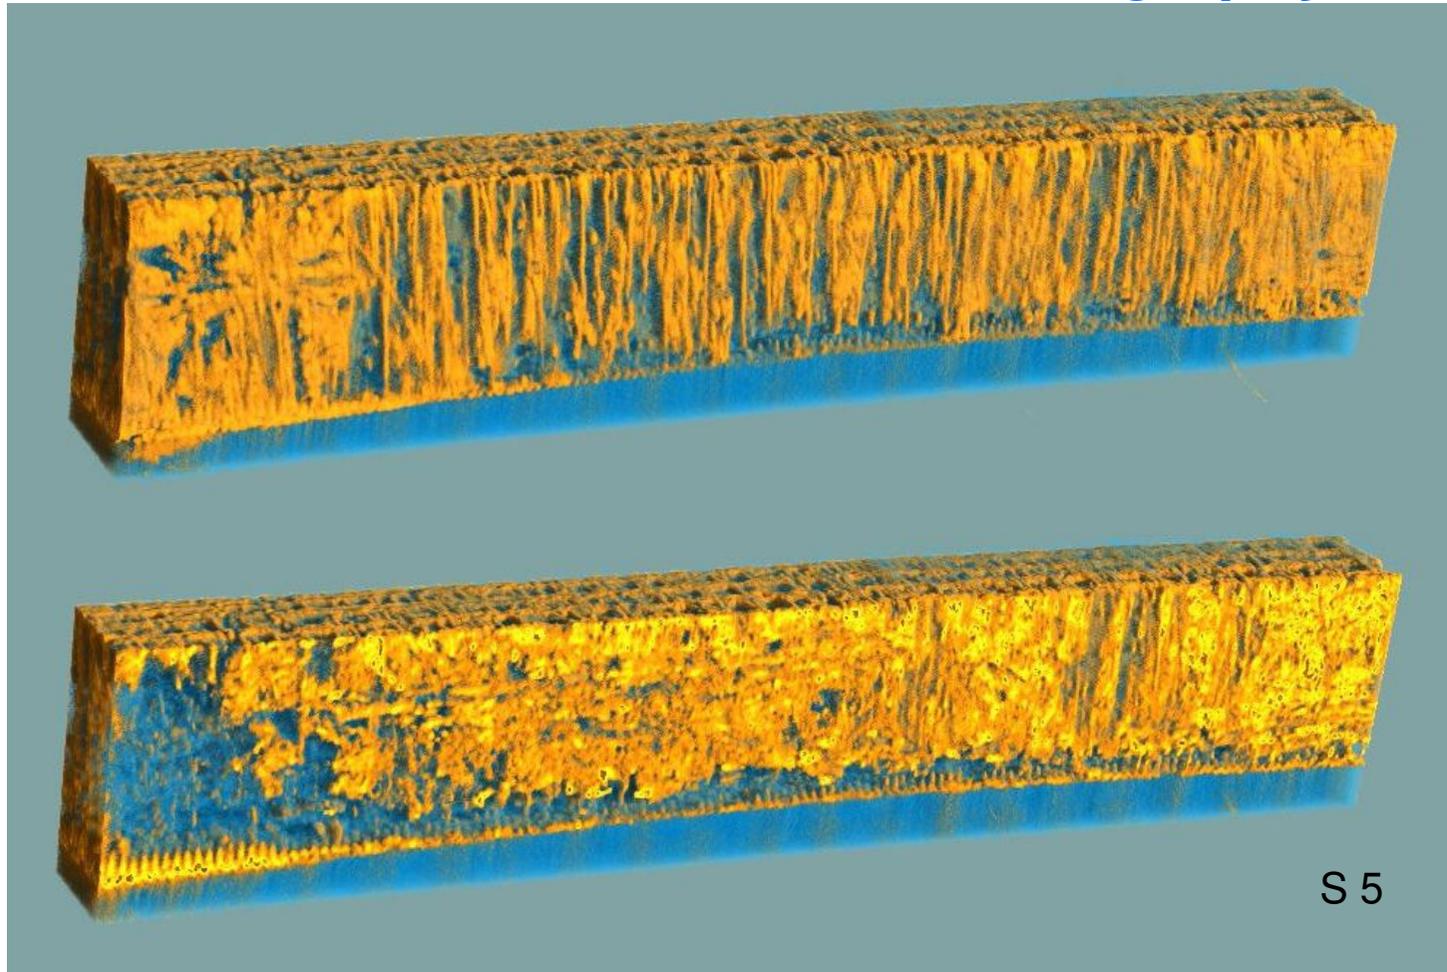
Two more views with different fibre planes (S5)

The perpendicular oriented ex-pitch fibre bundles are visible in the top image, the parallel oriented ex-PAN fibrous webs are visible in the bottom image.

The delamination is visible filled with Gd agent.

- The **extension** of the microscopically identified crack could be visualized und measured.
- The 8.5 mm long total delamination moves to a partially bonded area up to 16.7 mm length.
- The central area of the loaded zone (16.7 to 25 mm) shows complete bonding. A minor infiltration of Gd in the remaining length of the sample is a sign of formation of **micro-fissures** in the CFC/AMC interface due to the cyclic heat loading.
- However, the IR surface temperature measurement during the loading confirmed the **full heat transfer capability** of the interface despite the identified partial delamination.

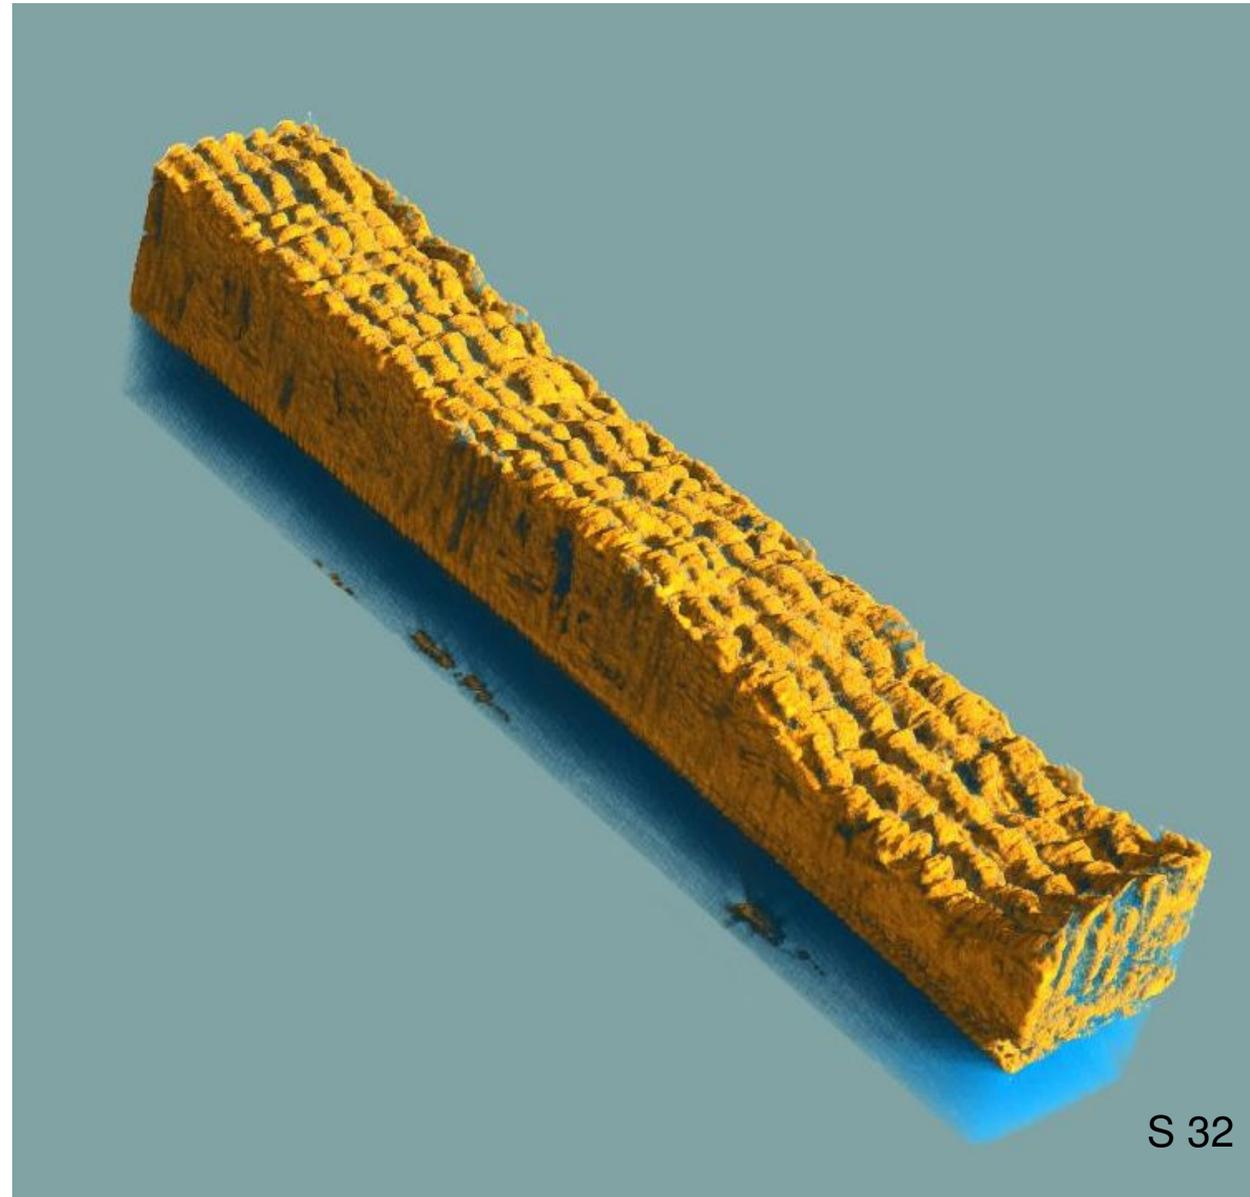
**Destroyed surface
after 32 MW/m²
heat loading.**

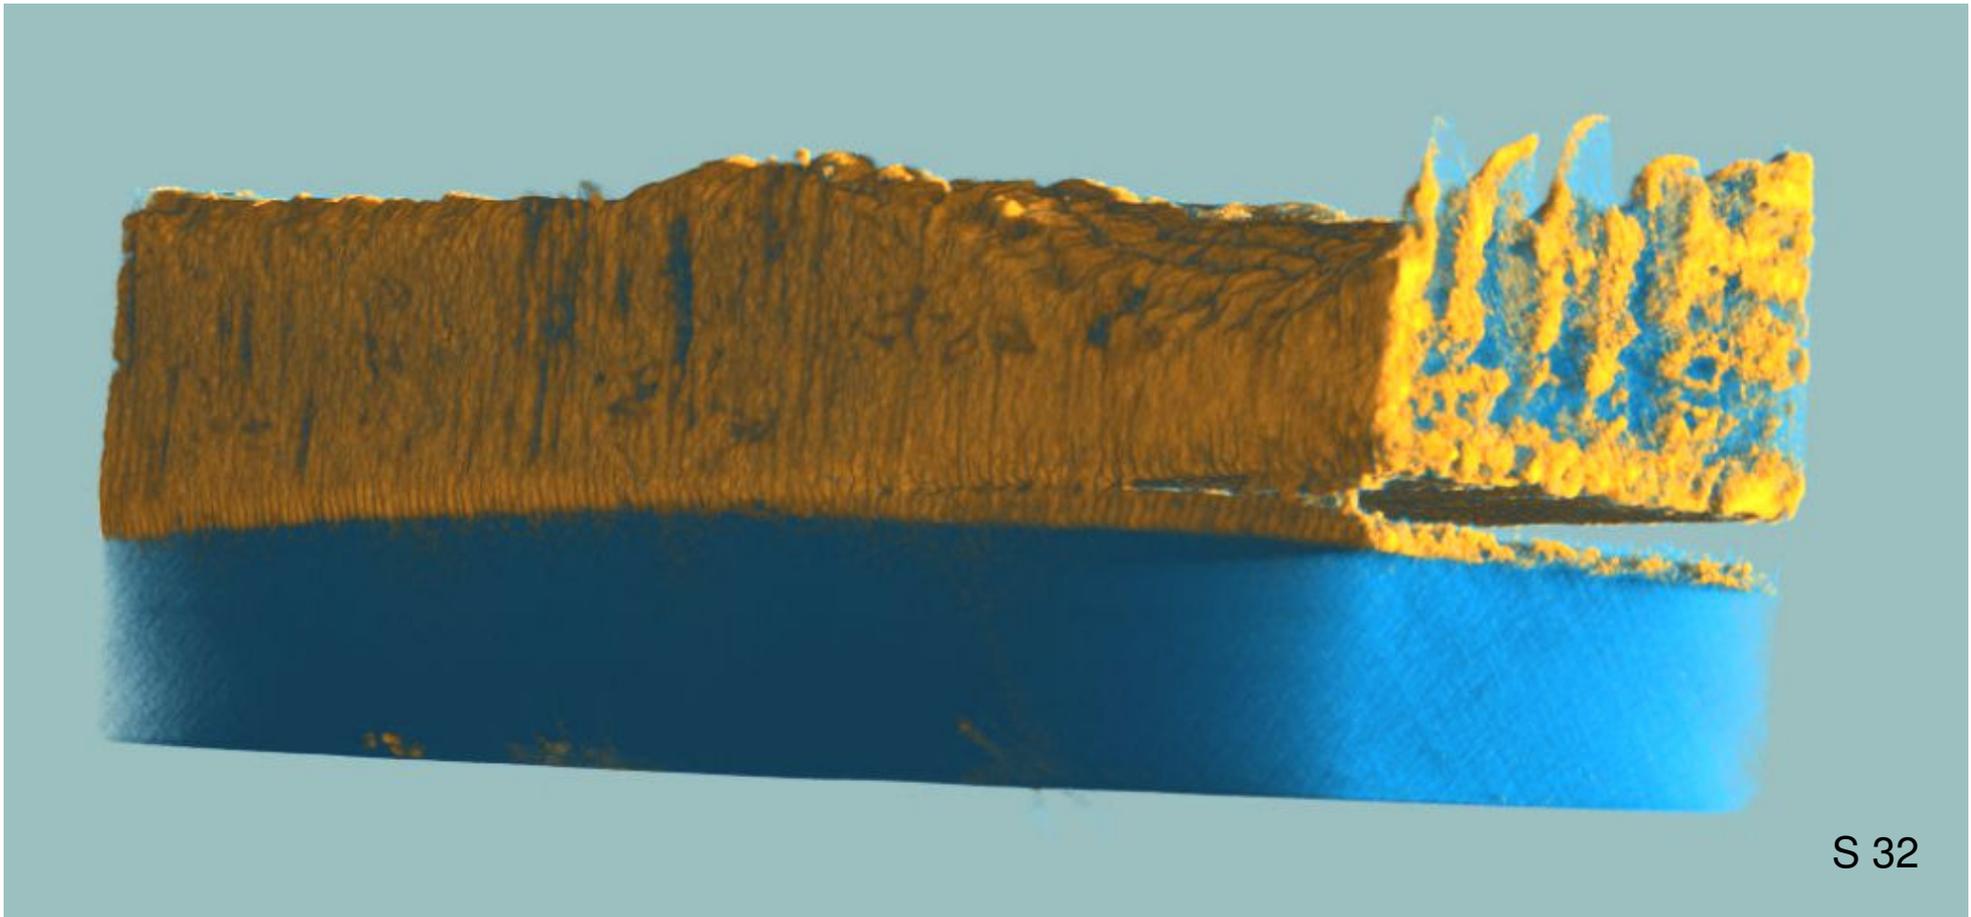
**View of the large delamination after 32 MW/m² heat loading.
The CFC structure is strongly damaged, but the ex-pitch fibre bundles perpendicular to the cooling structure survived. The crack is so big that the contrast agent ran out and left it empty.**

- The results of 3D analysis along different planes through the sample explain the **evaporation mechanism of CFC**. The **ex-pitch fibre planes essentially survived** while the matrix and the ex-pan fibres are strongly damaged.
- From these observations it can be concluded that the CFC is able to withstand a limited number of overload pulses without total failure. The **remaining ex-pitch fibre bundles ensure a reduced functionality** of the CFC as plasma facing material.
