Neutron tomography as a new method for 3D structure analysis of CFC as plasma facing material

B. Schillinger, H. Greuner, Ch. Linsmeier

Aim: Investigation of Carbon Fibre Composite (CFC) morphology modifications of highly heat loaded divertor components after cyclic heat load experiments.

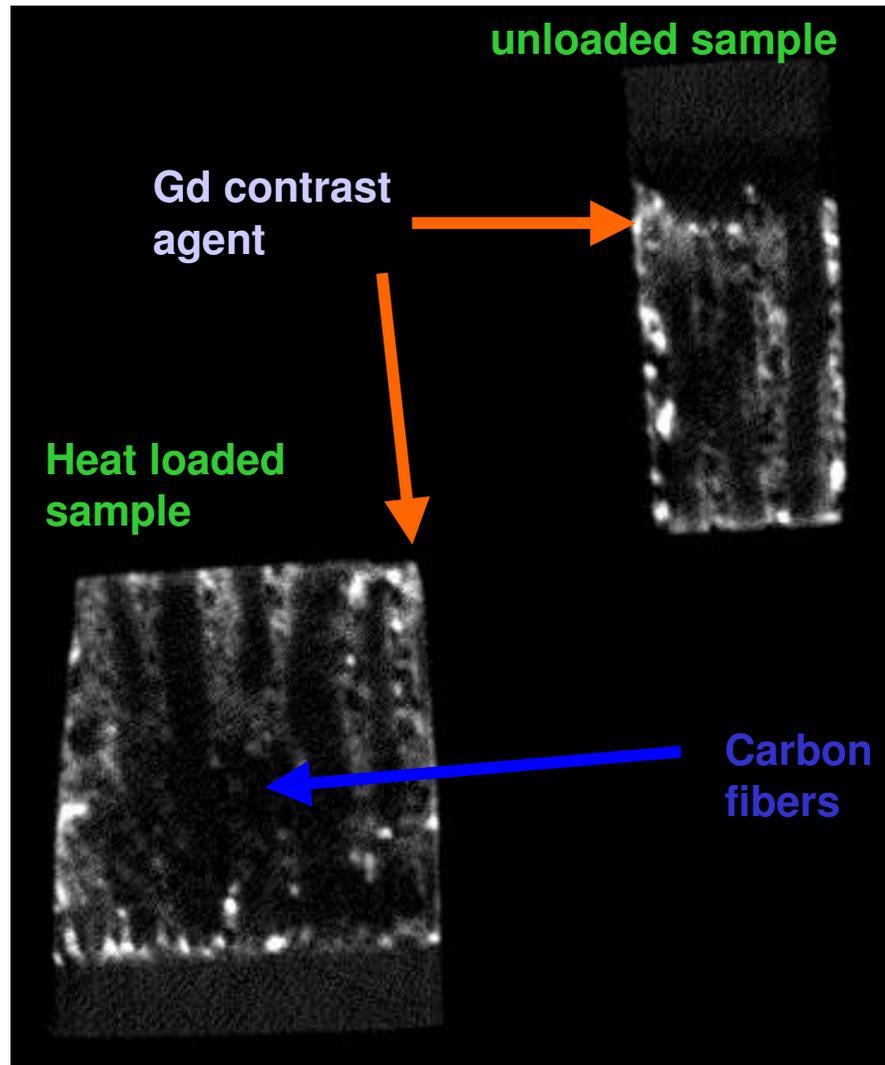
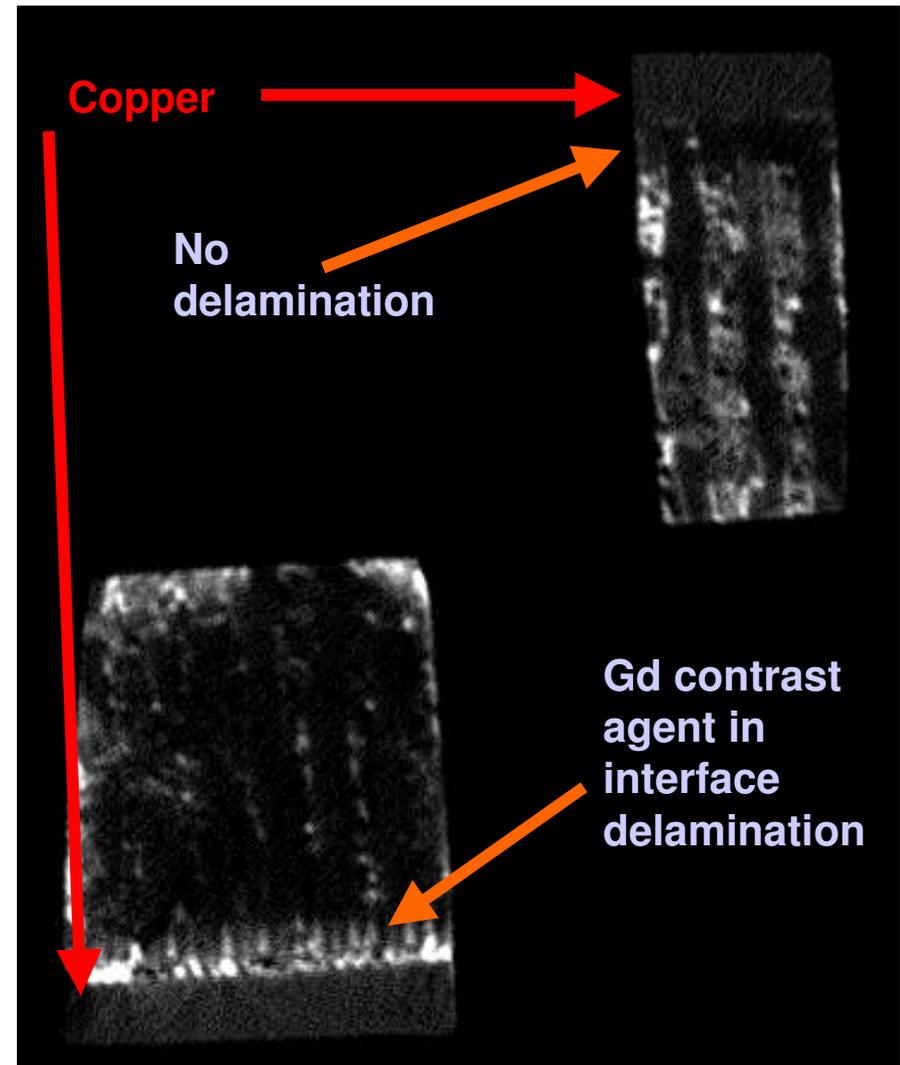
The heat loaded sample is on the left (5000 pulses) and the unloaded sample on the right.

- There are no significant differences in the bulk carbon fiber blocks of the loaded and unloaded sample → **No deterioration of the CFC block**
- Obvious **delamination** between the copper and CFC block in the loaded sample, going into very fine details
- No delamination, not even porosity, in the interface of the unloaded sample

- The **extension** of the microscopically identified crack could be visualized und measured.
- The 8.5 mm long total delamination moves to a partially bonded area up to 16.7 mm length.
- The central area of the loaded zone (16.7 to 25 mm) shows complete bonding. A minor infiltration of Gd in the remaining length of the sample is a sign of formation of **micro-fissures** in the CFC/AMC interface due to the cyclic heat loading.
- However, the IR surface temperature measurement during the loading confirmed the **full heat transfer capability** of the interface despite the identified partial delamination.

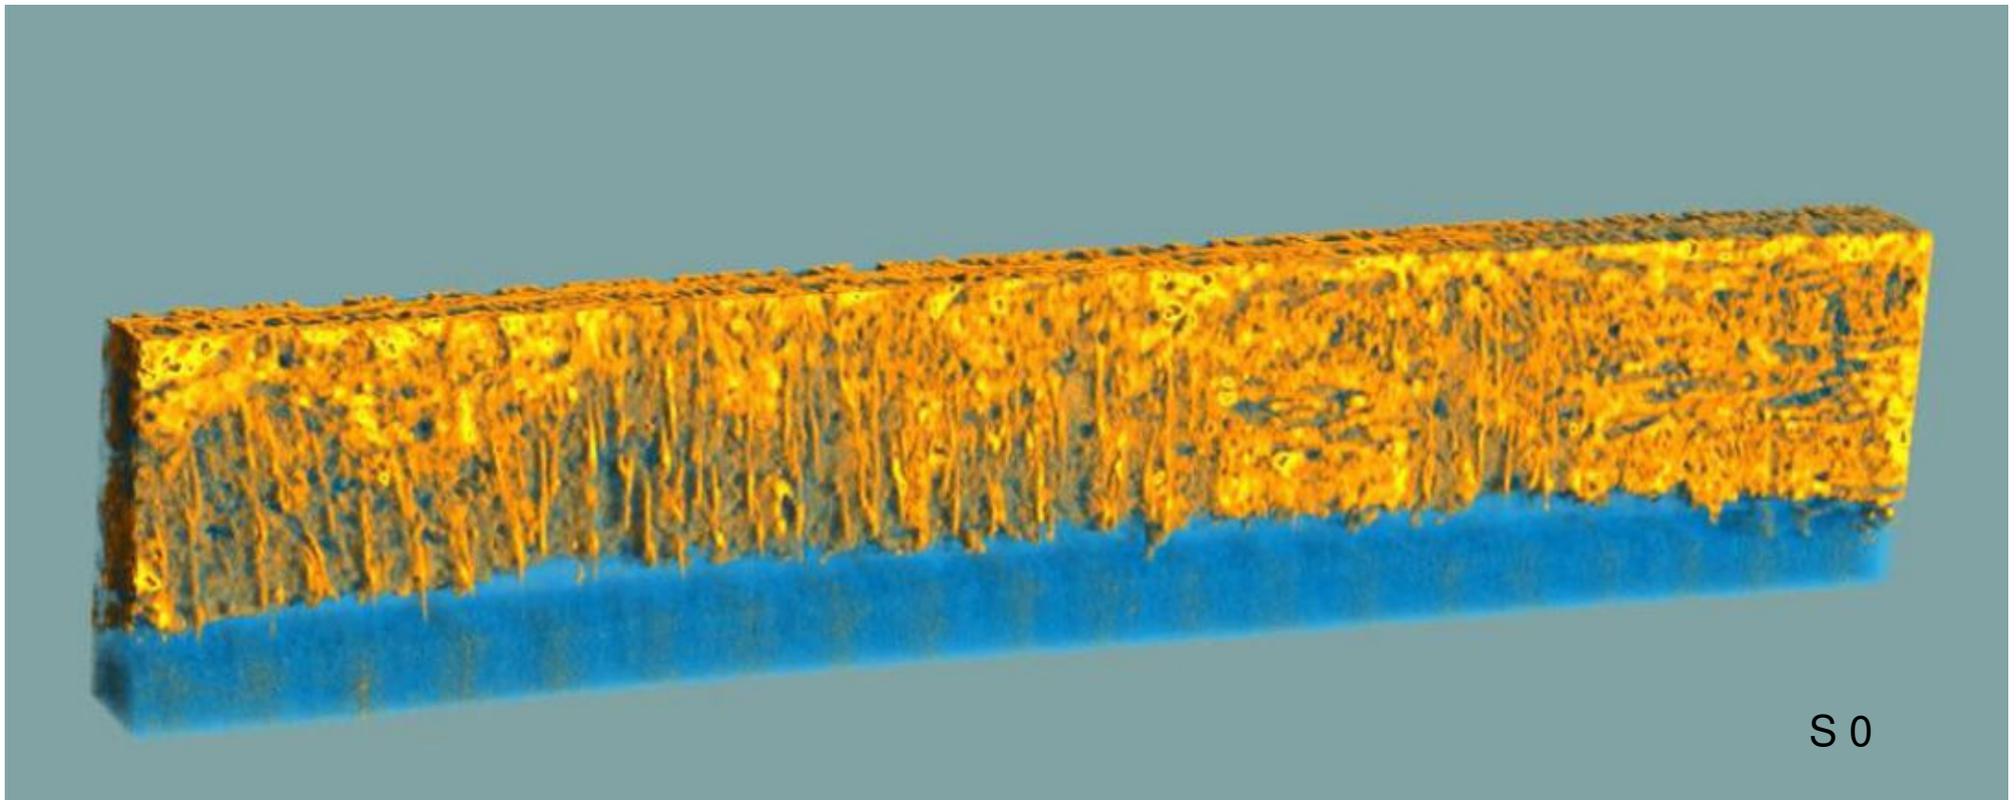
3D reconstruction of the unloaded sample.

Blue bottom: AMC/Cu. Yellow top: absorption by Gd.

**The viewing area crosses two CFC fibre planes.
The perpendicular oriented ex-pitch fibre bundles are visible in the left part,
the parallel oriented ex-PAN fibrous webs are visible in the right part.
The initial CFC/Cu interface forms a barrier against the infiltration of Gd.
Only a few isolated pores in the AMC layer could be revealed.**
