Plasma induced surface modification in the divertor strike point region of ASDEX Upgrade

E. Fortuna⁻Zalesna^a*, M. Rasinski^a, M. Pisarek^a, K. Rozniatowski^a, M. Mayer^b, R. Neu^b, K. J. Kurzydlowski^a, ASDEX Upgrade Team^b

PFMC 13, May 9-13, 2011, Rosenheim, Germany

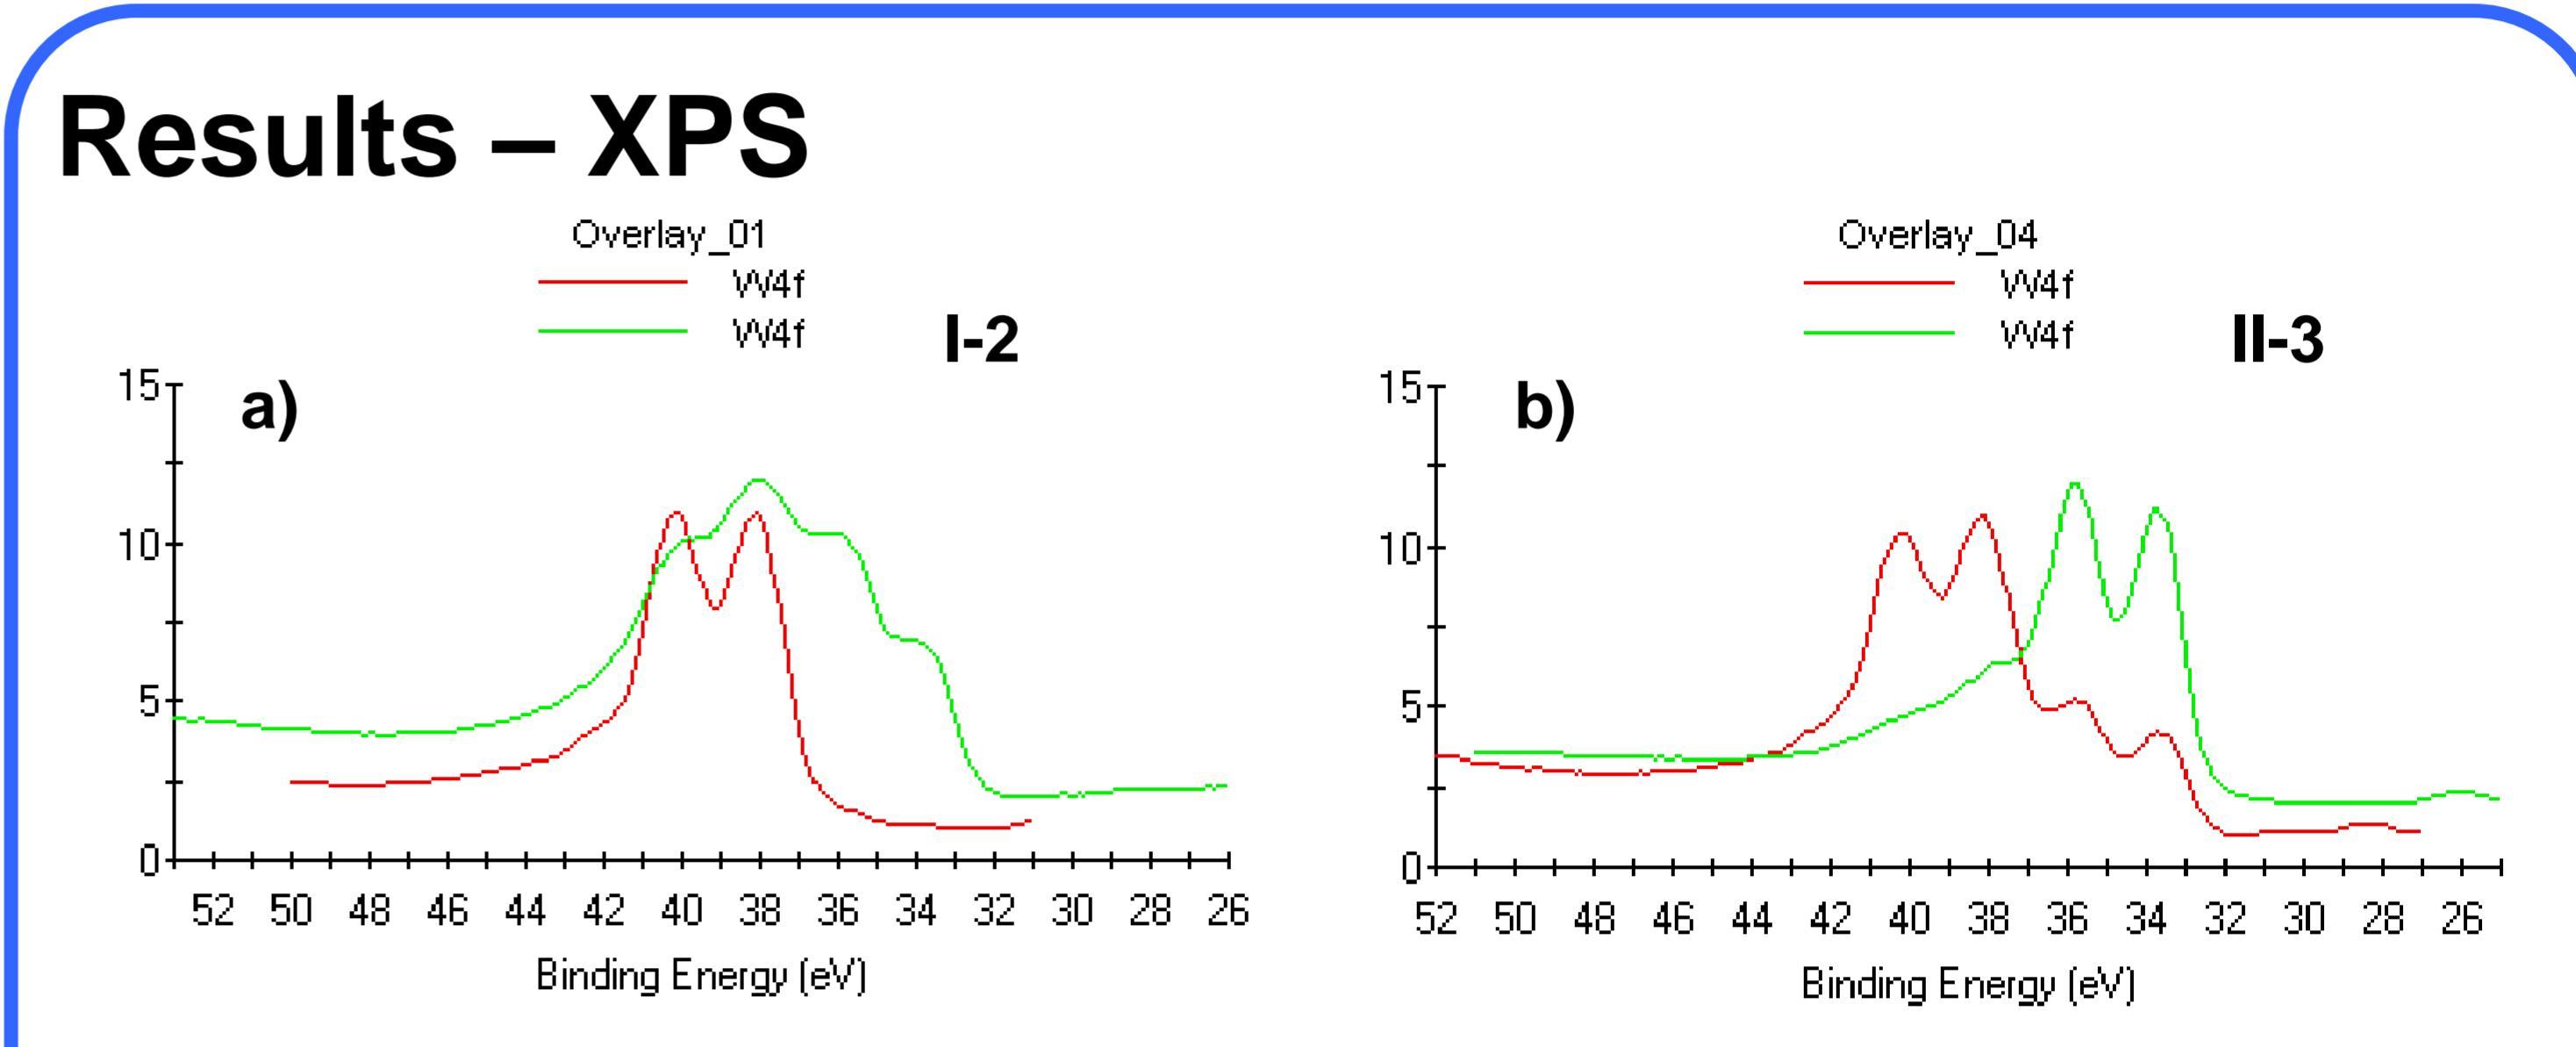
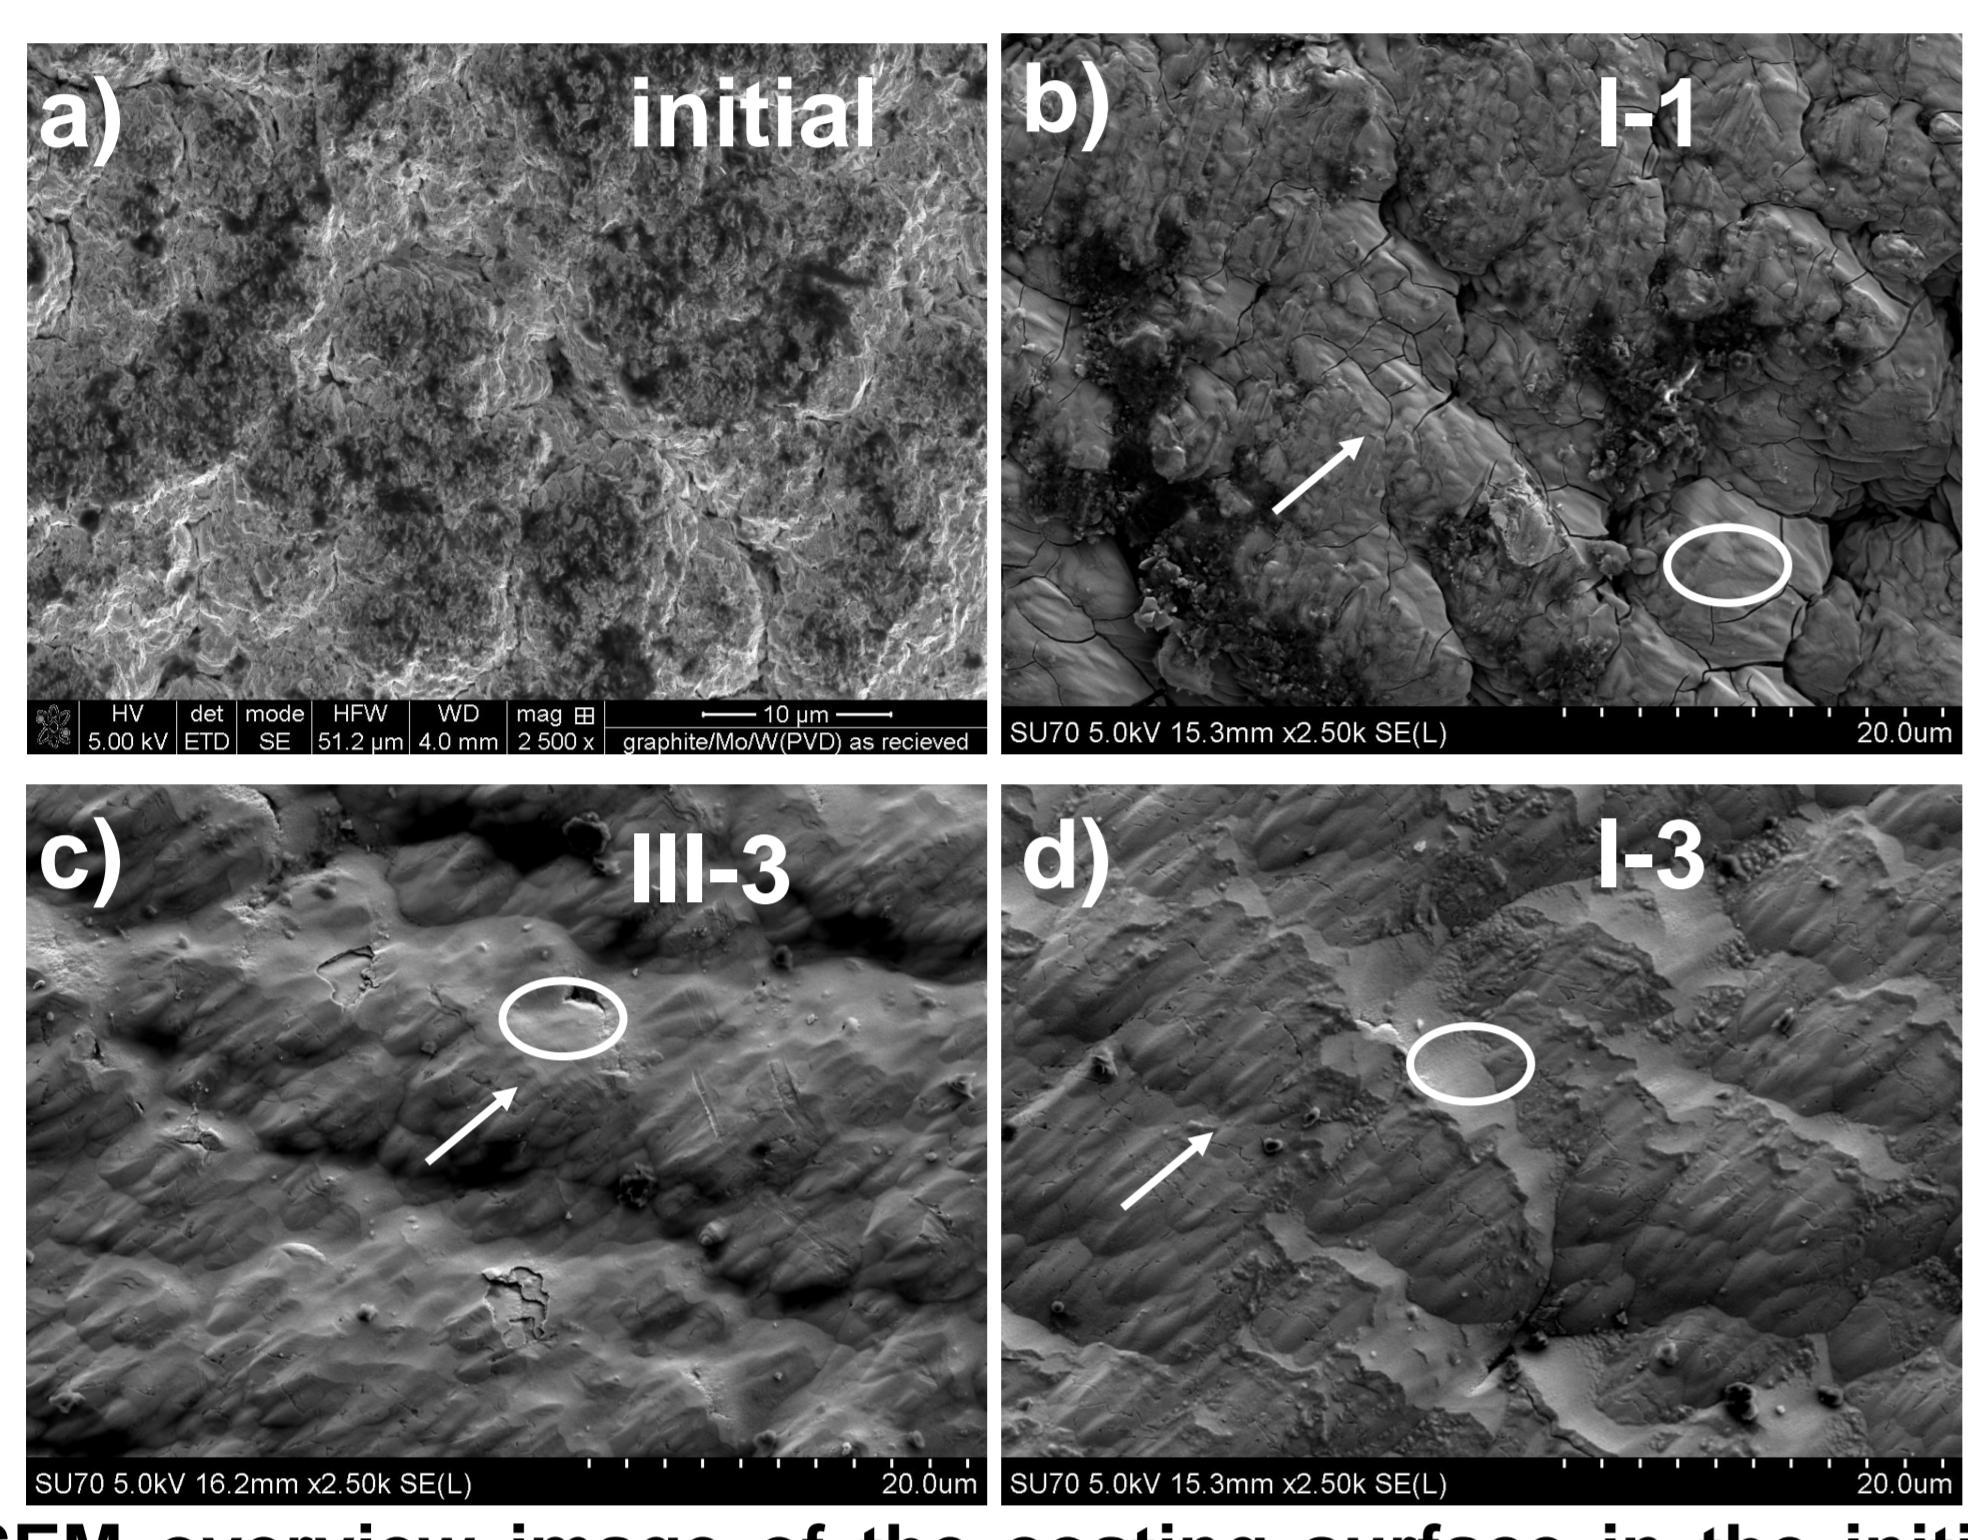
SEM overview image of the coating surface in the initial state (a) and after the campaign (b-d) together with a scheme of the divertor cross-section in ASDEX Upgrade. Arrows indicate directional erosion. Ovals indicate local re-deposition locations.

The erosion of the samples has clear directional character, which agrees with the direction of the particles flux/magnetic field lines.

- Two processes were observed: (a) changes brought about by erosion and (b) (re-) deposition.
- \checkmark The deposit distribution is inhomogeneous. It forms mainly in the shadowed areas,

often at the slopes of the irregularities of the surface.

✓ It has been generally observed that the surface morphology of the tungsten coating after the exposure shows a directional character of erosion and deposition. The deposits form mostly in the shadowed areas. Their thickness, according to FIB/STEM examinations varies from 200 nm to 1.5 µm, depending on the sample location and amount of received flux. The investigations revealed mostly W and W/O deposits. The structure of the re-deposited tungsten contains many small inclusions of light elements mixed with tungsten.
✓ The XPS examinations confirmed that the main constituents of the deposits are tungsten, oxygen and carbon. Residues of iron were also observed. The amount and morphology of the boron deposition varied strongly with the position of the sample.
✓ The roughness measurements confirmed surface smoothening caused by erosion.

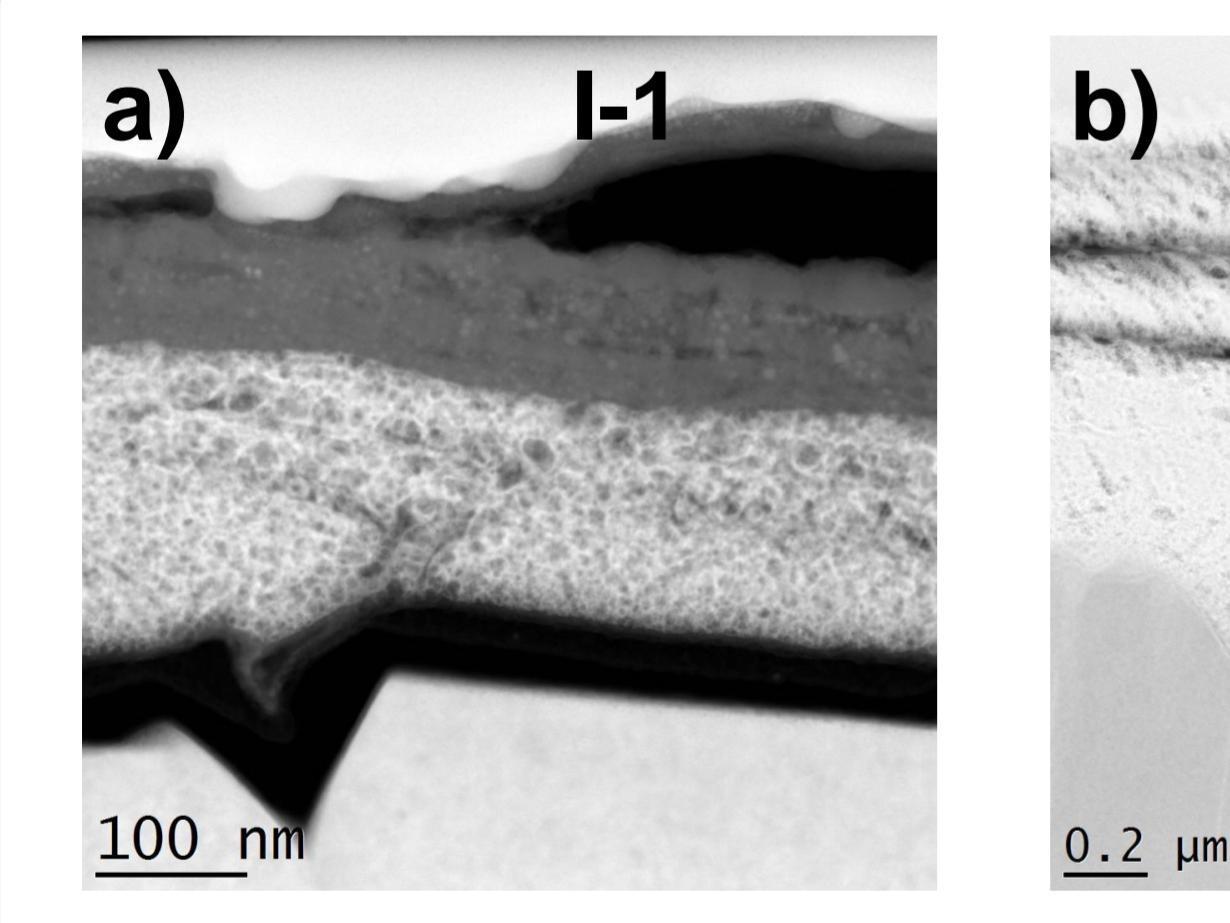
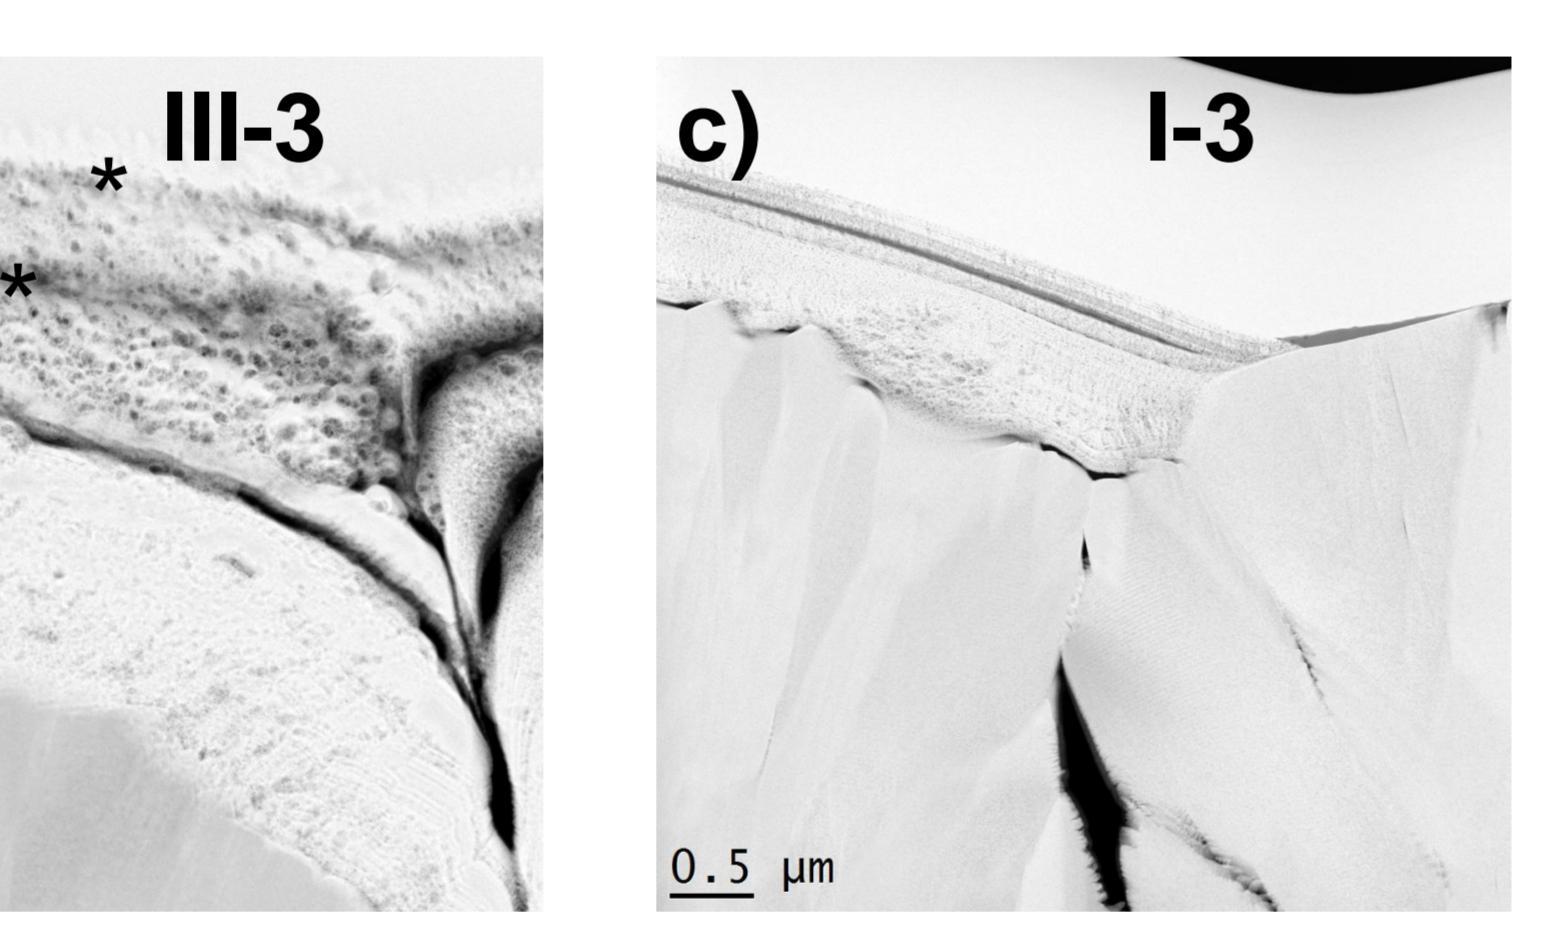
STEM Z-contrast images representing cross-sections of eroded and deposited layers

- ✓ The thickness of re-deposited material varies from the 300 nm for sample I-1 to 1-1.5 μ m in the case of samples III-3 and I-3 (the lamellas were cut from the shadowed areas).
- \checkmark Re-deposited tungsten contains inclusions of light materials mixed with tungsten, with the diameter of inclusions from 3-4 to tens of nm. The embedding matrix is tungsten.
- ✓ Boronizations performed during the campaign resulted in the presence of about 80 nm sub-layers being a mixture of B, C and O (*).

The tungsten coating was not fully eroded at ant place.

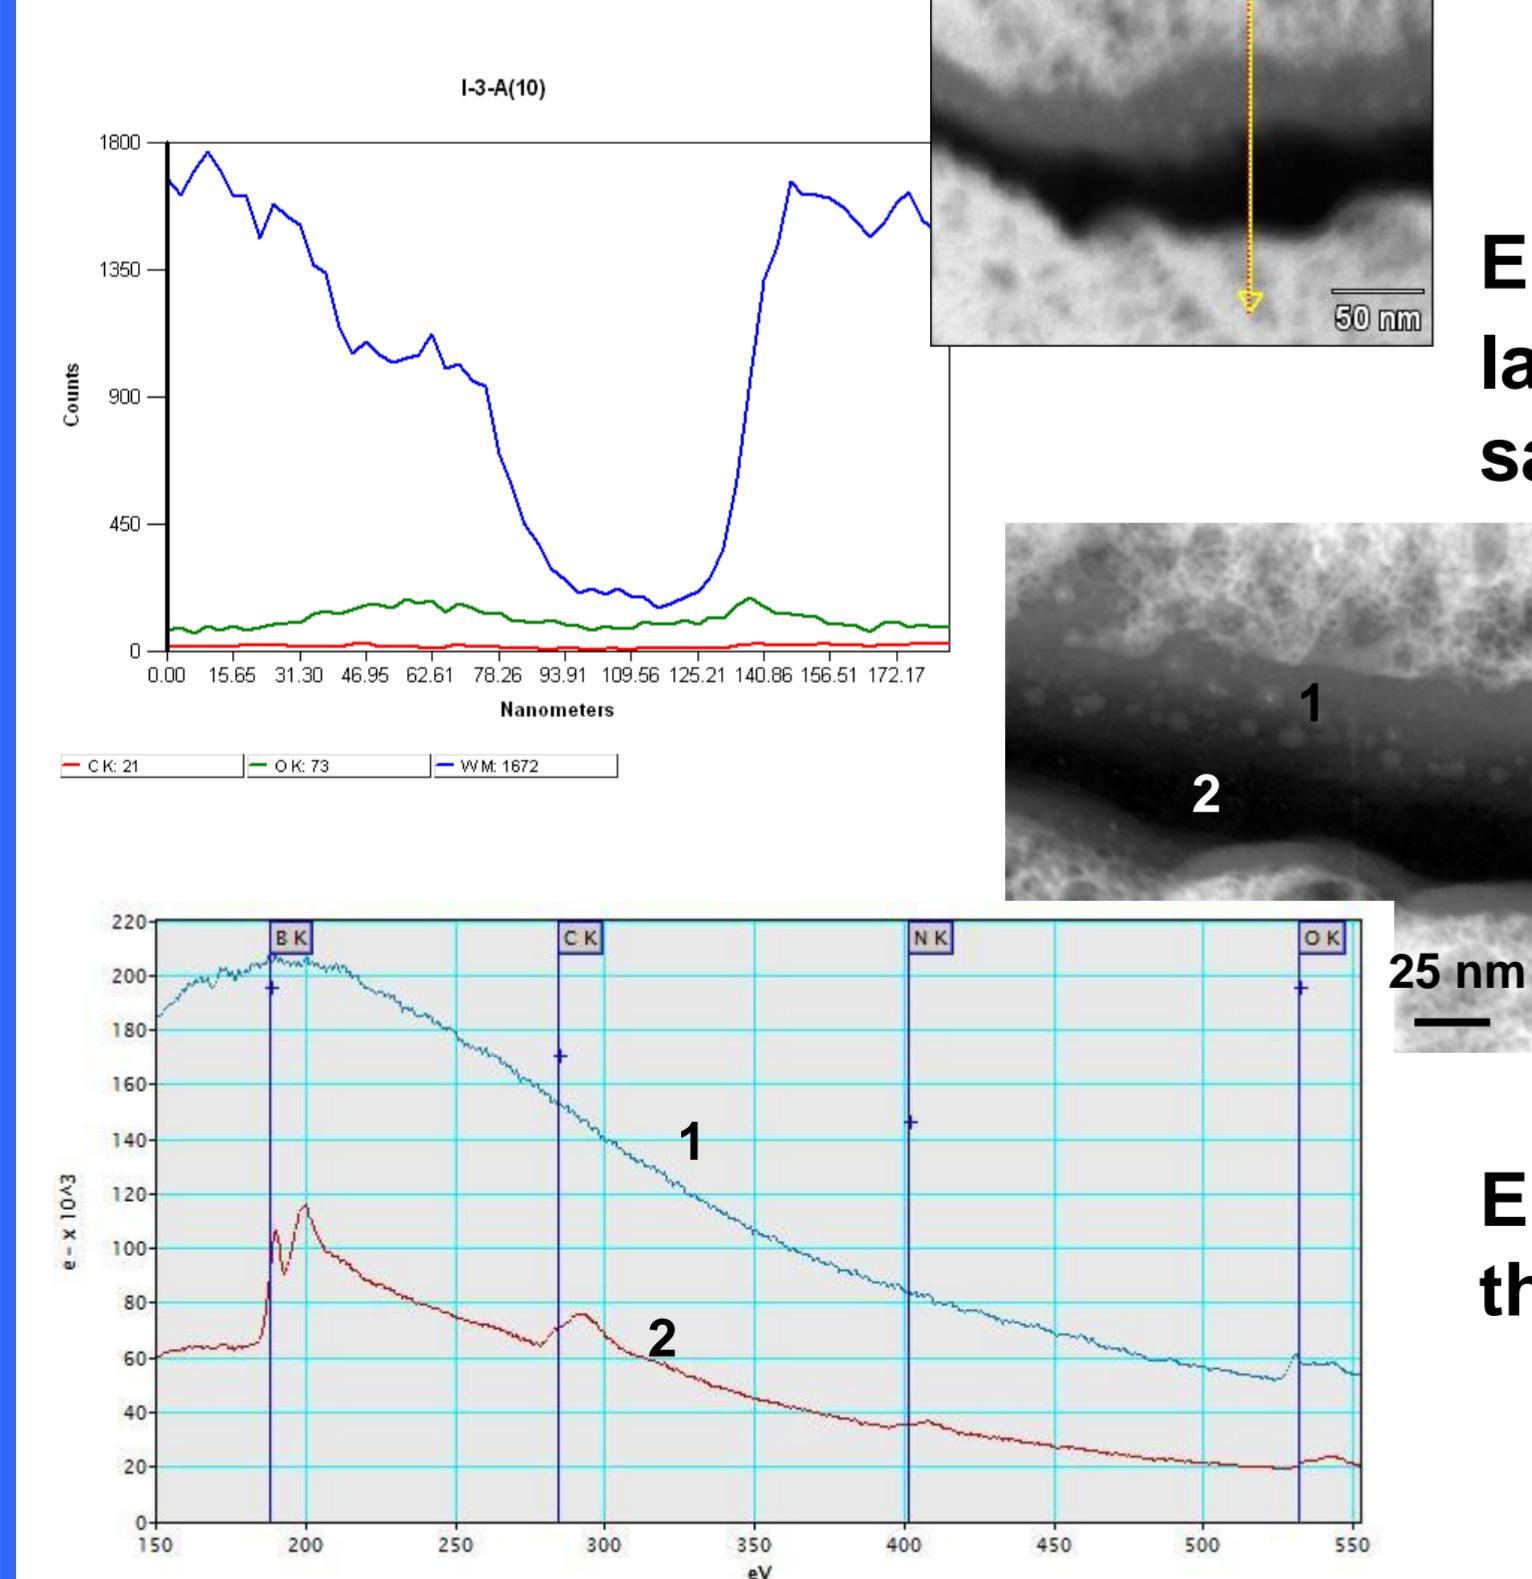
EDX line scan through one of the sublayers present in the grown deposit on sample III-3

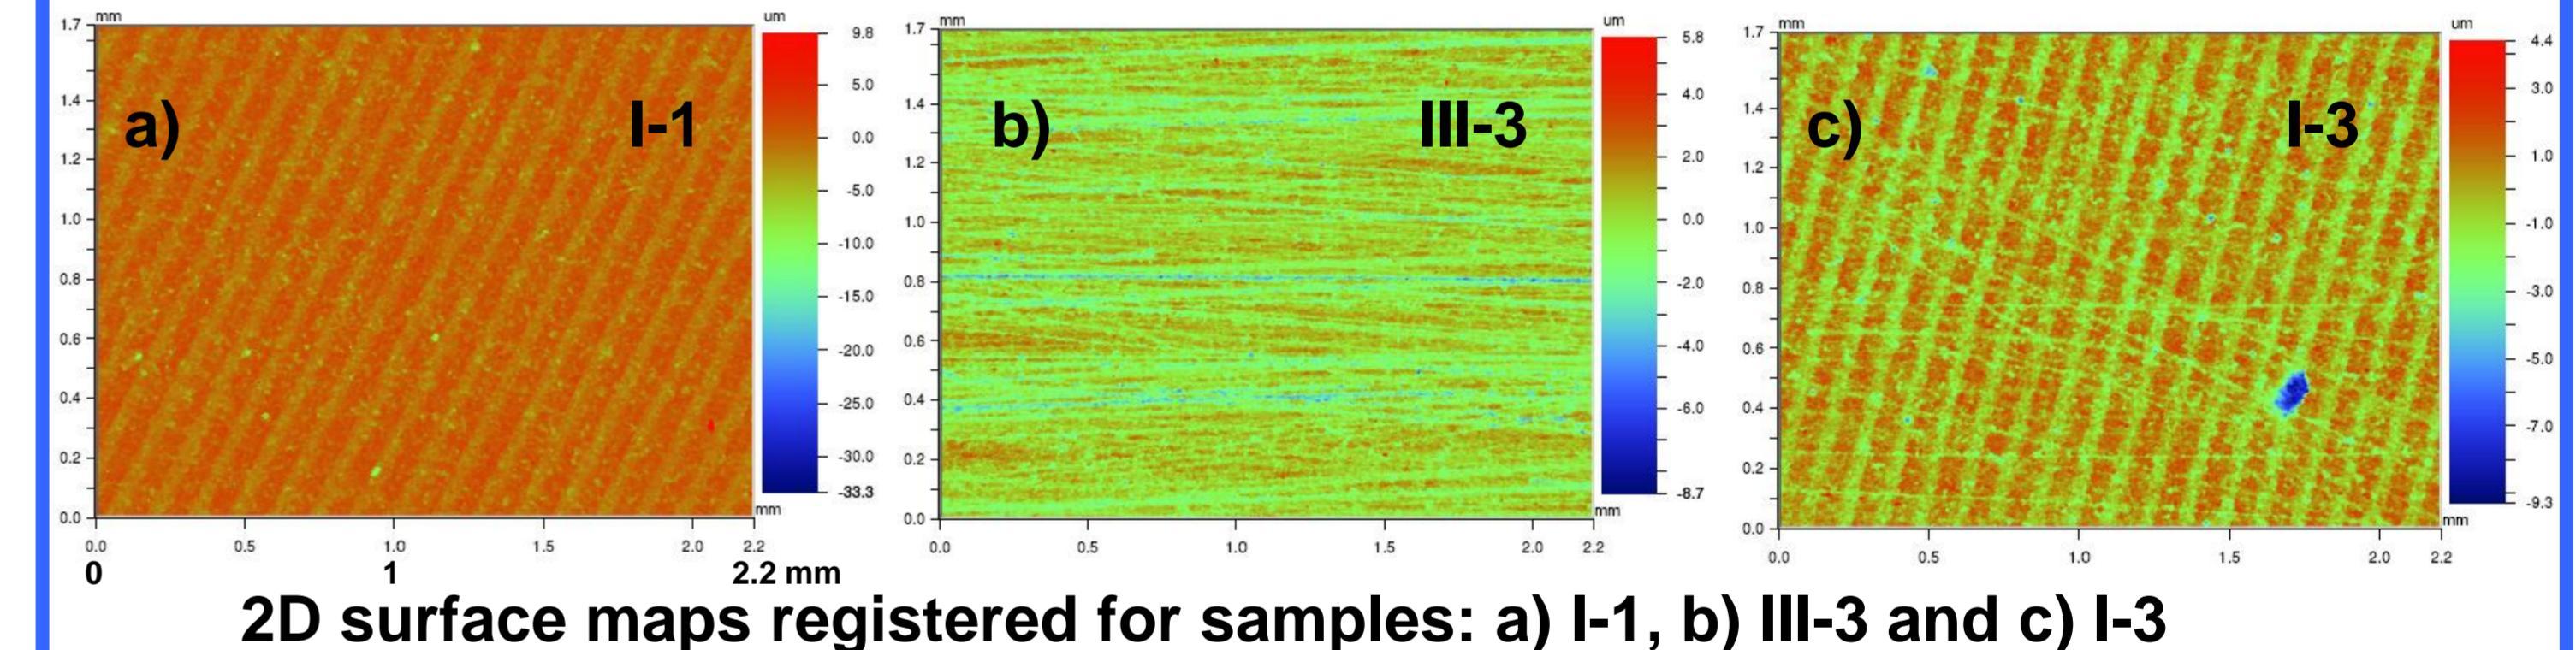
The largest roughness was measured for sample I-1, which still showed the original tungsten/ substrate structure. The intermediate value was obtained for sample III-3 and the smallest one for sample I-3, which was also subjected to the highest flux. The results are in agreement with the microscopic observations.
