Overview of JET post-mortem results following the 2007-9 operational period, and comparisons with previous campaigns

Plasma facing Components: Erosion/Deposition (Global trends)

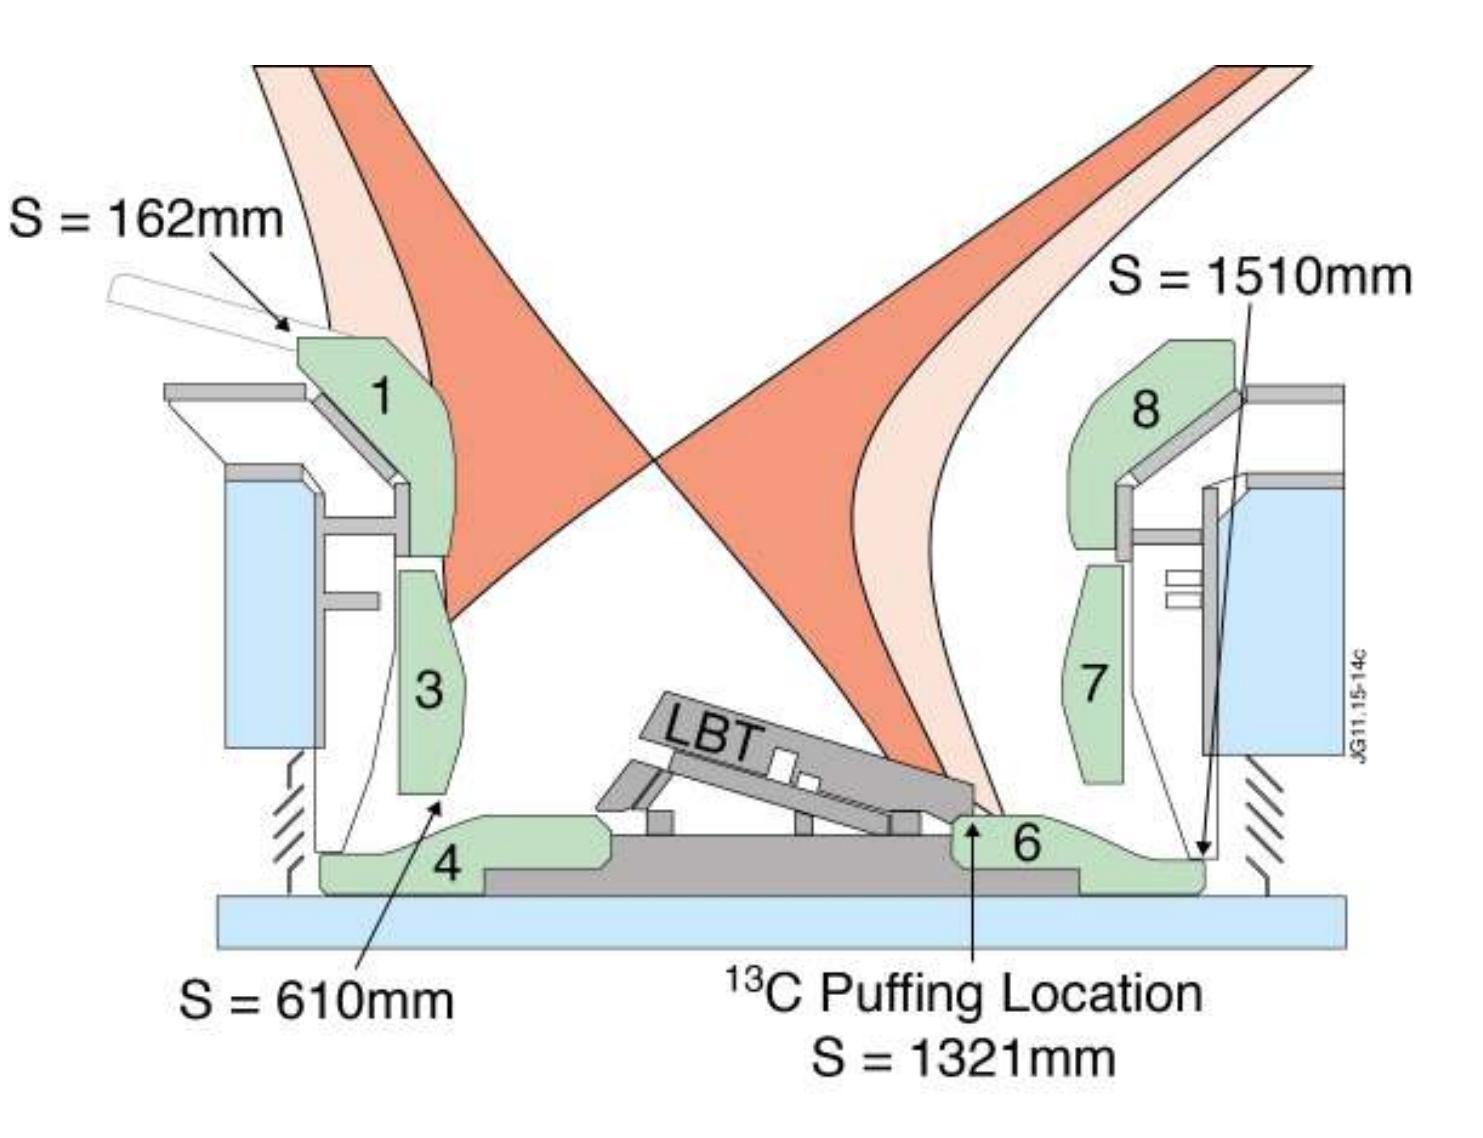
Deposits in inner SOL

Heavy deposition of C, Be and other impurities in inner SOL, chemical sputtering of C and transport to corner, resulting in enhanced Be/C ratios.

Values of Be/C in outer micron up to 4.5 – a record for JET!

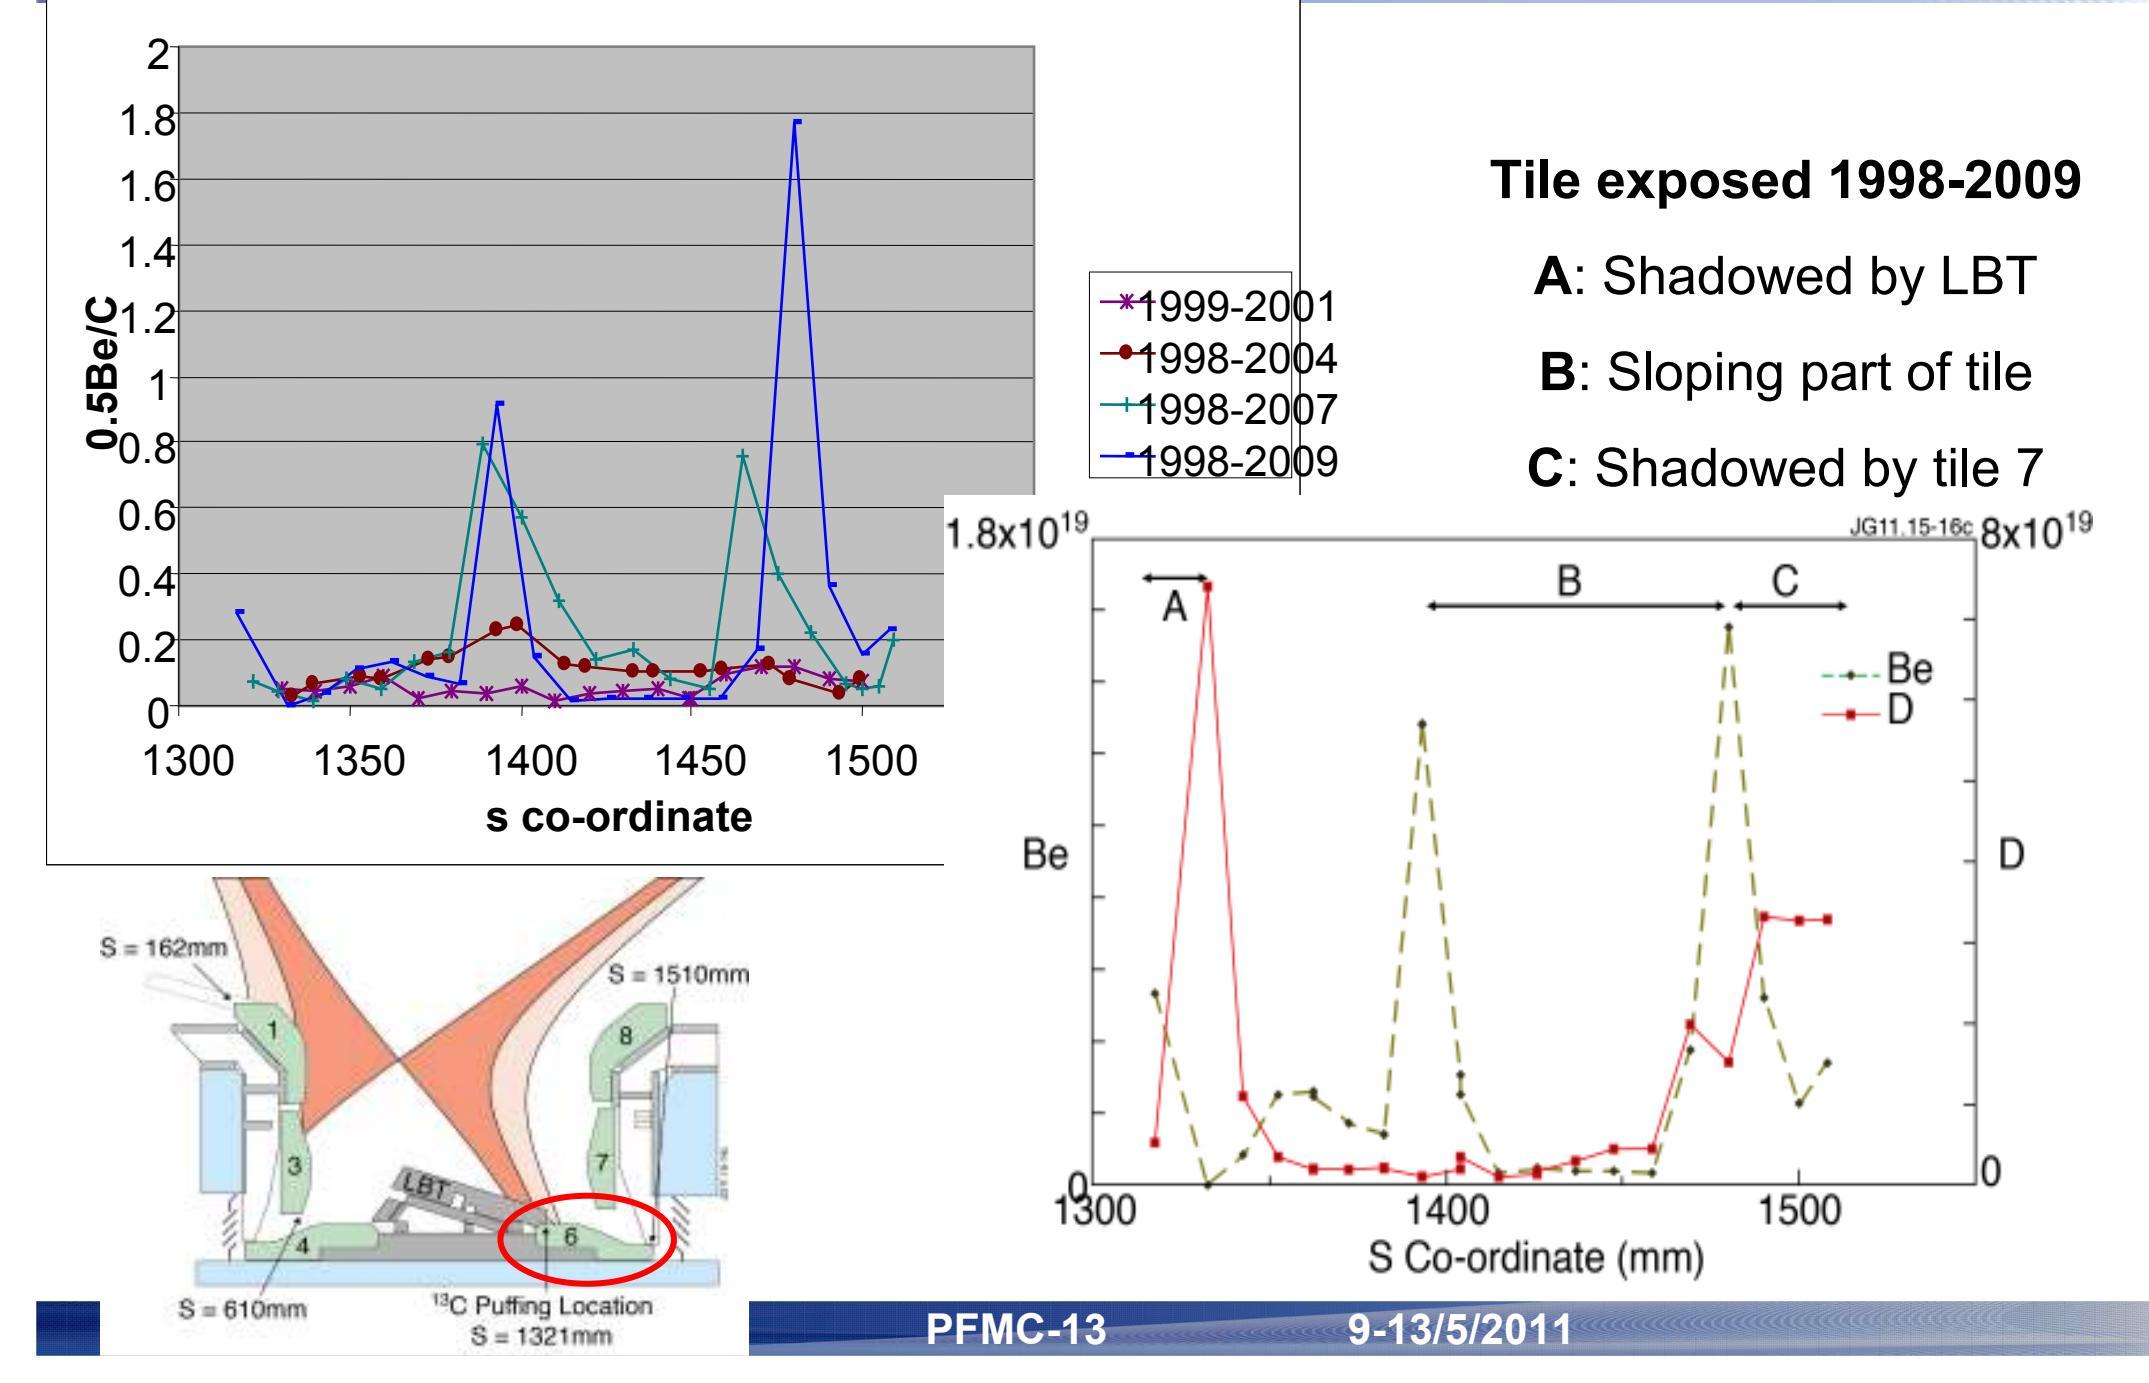
Updated comparison of Be/C on tile 6

14BW G6B 2004-2009

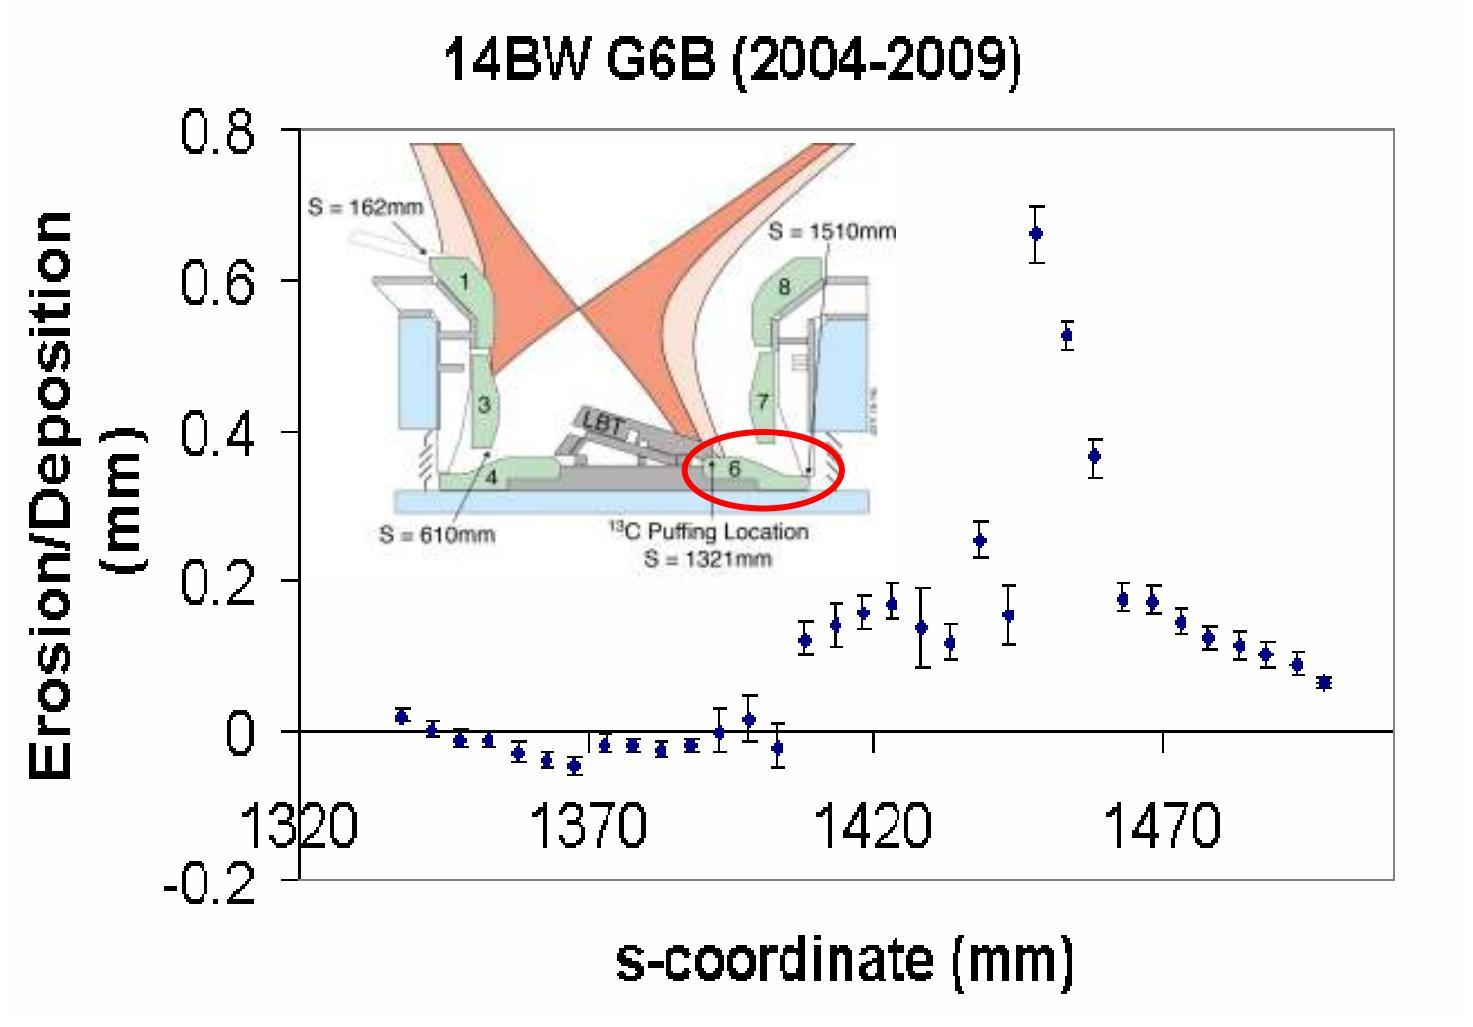
Tile profiling of divertor tile 6

Maximum deposition on tile of ~650 microns in 2005-9 compares with ~800 microns 1998-2007 (Likonen)

Position of peak thickness is not coincident with maximum Be/C

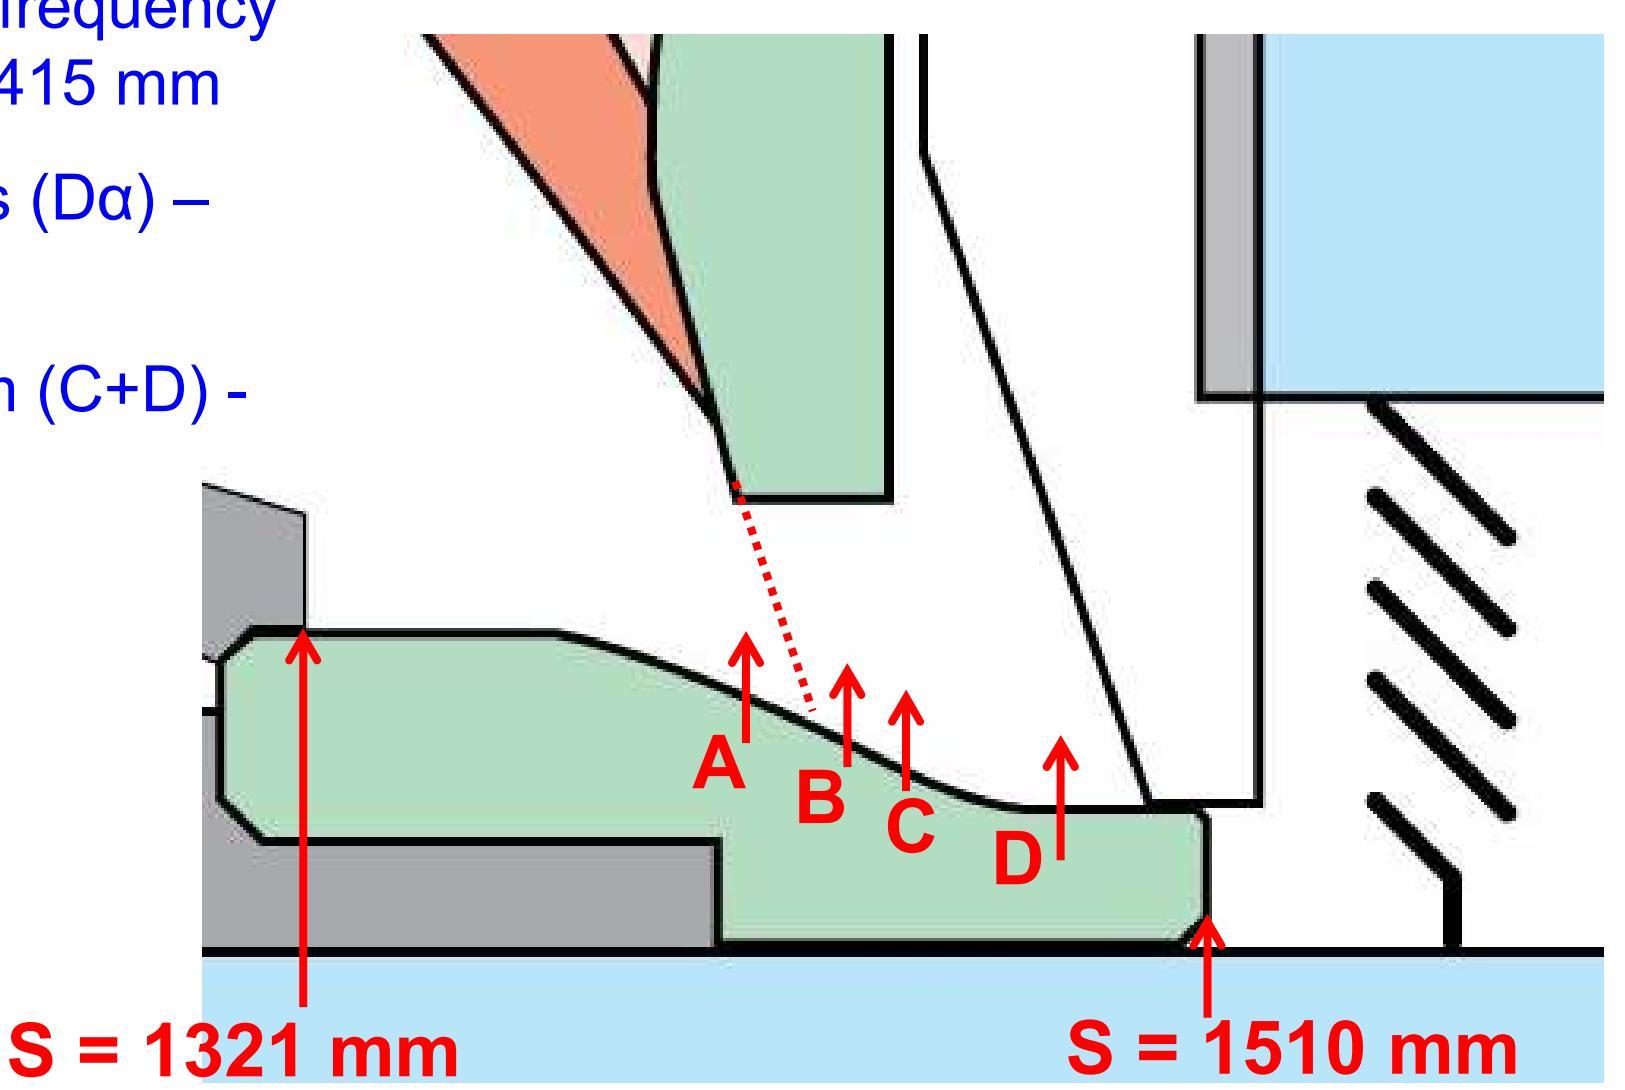
Transport at outer divertor corner

Positions of maxima

- A: Strike point frequency (magnetic) – 1415 mm
- B: Strike points (Dα) 1434 mm
- C: Thickest film (C+D) -1448 mm

D: Be/C ratio -1480 mm

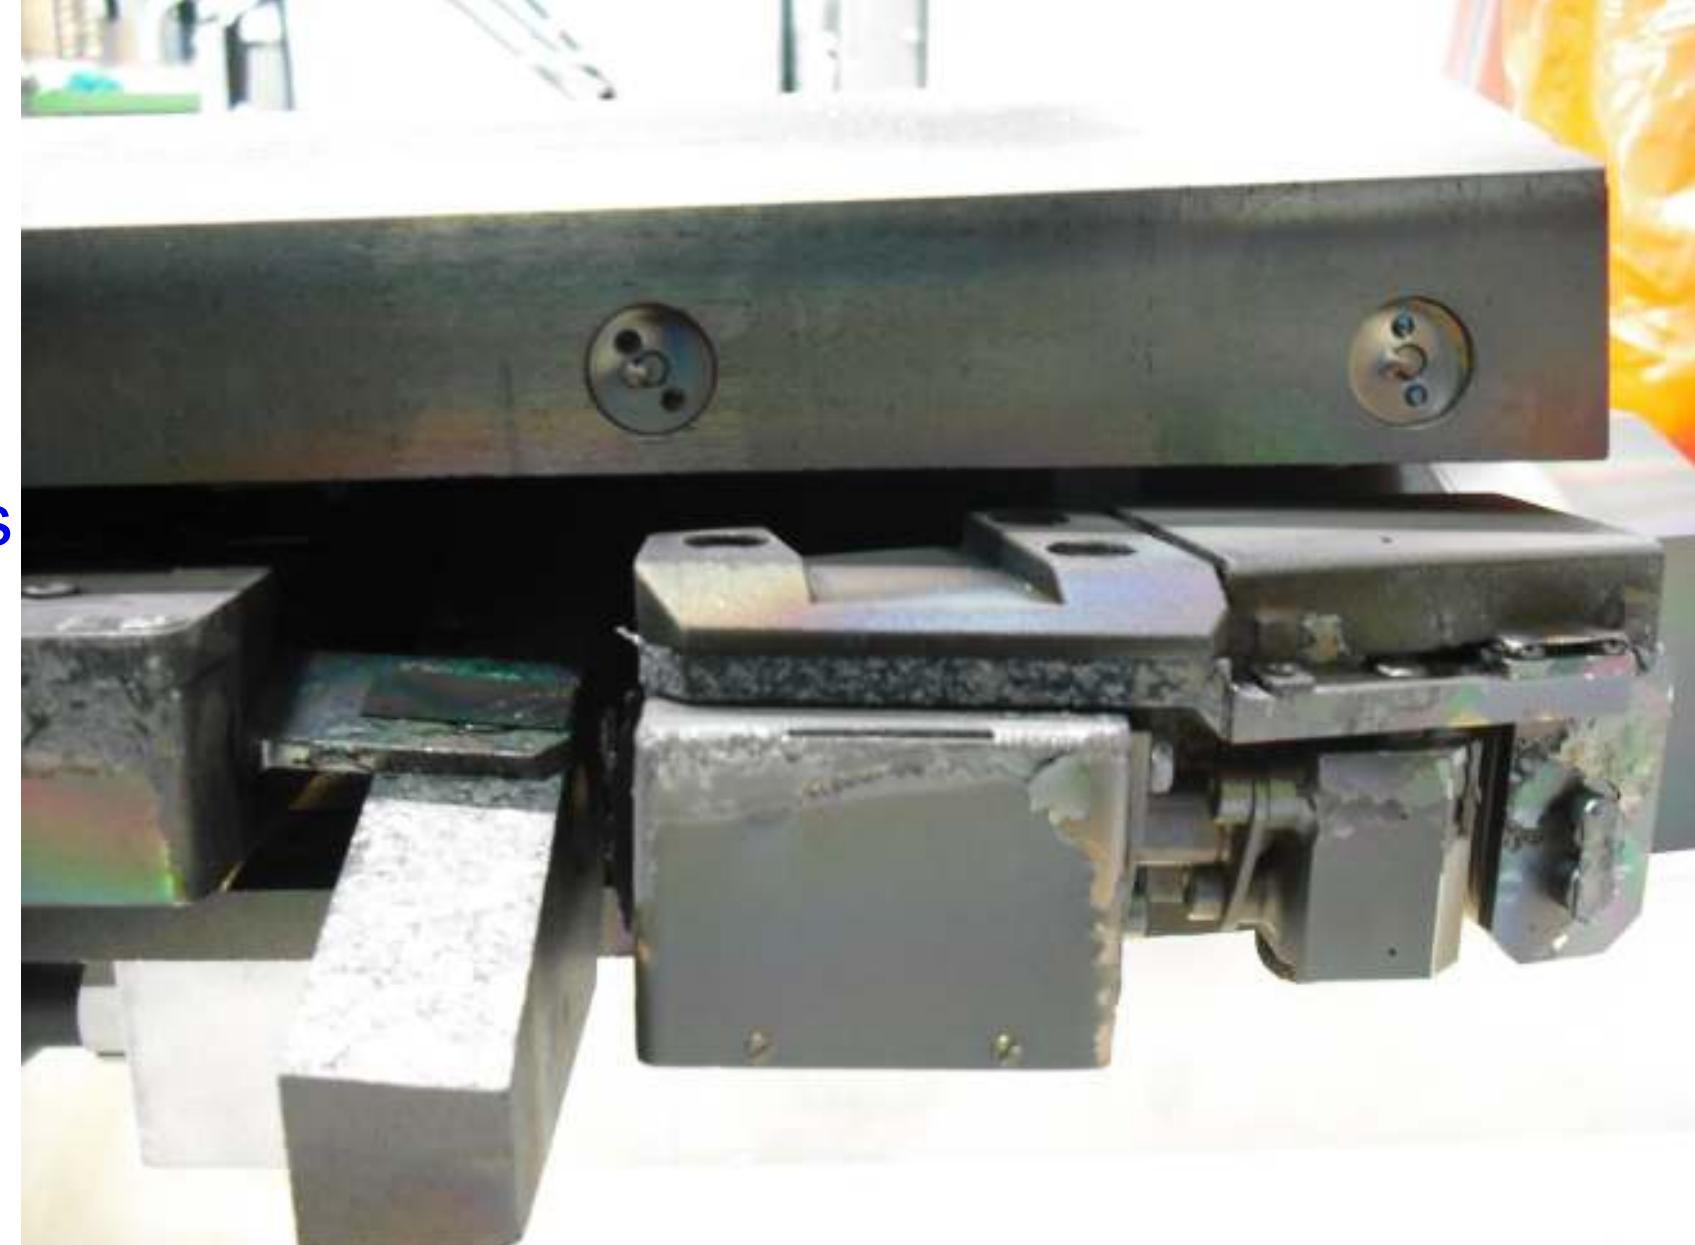
EFJET Bottom of outer carrier after 2007-9

Thick deposited films on/under diagnostics installed in 2007.

Note little deposition on end of tile 7

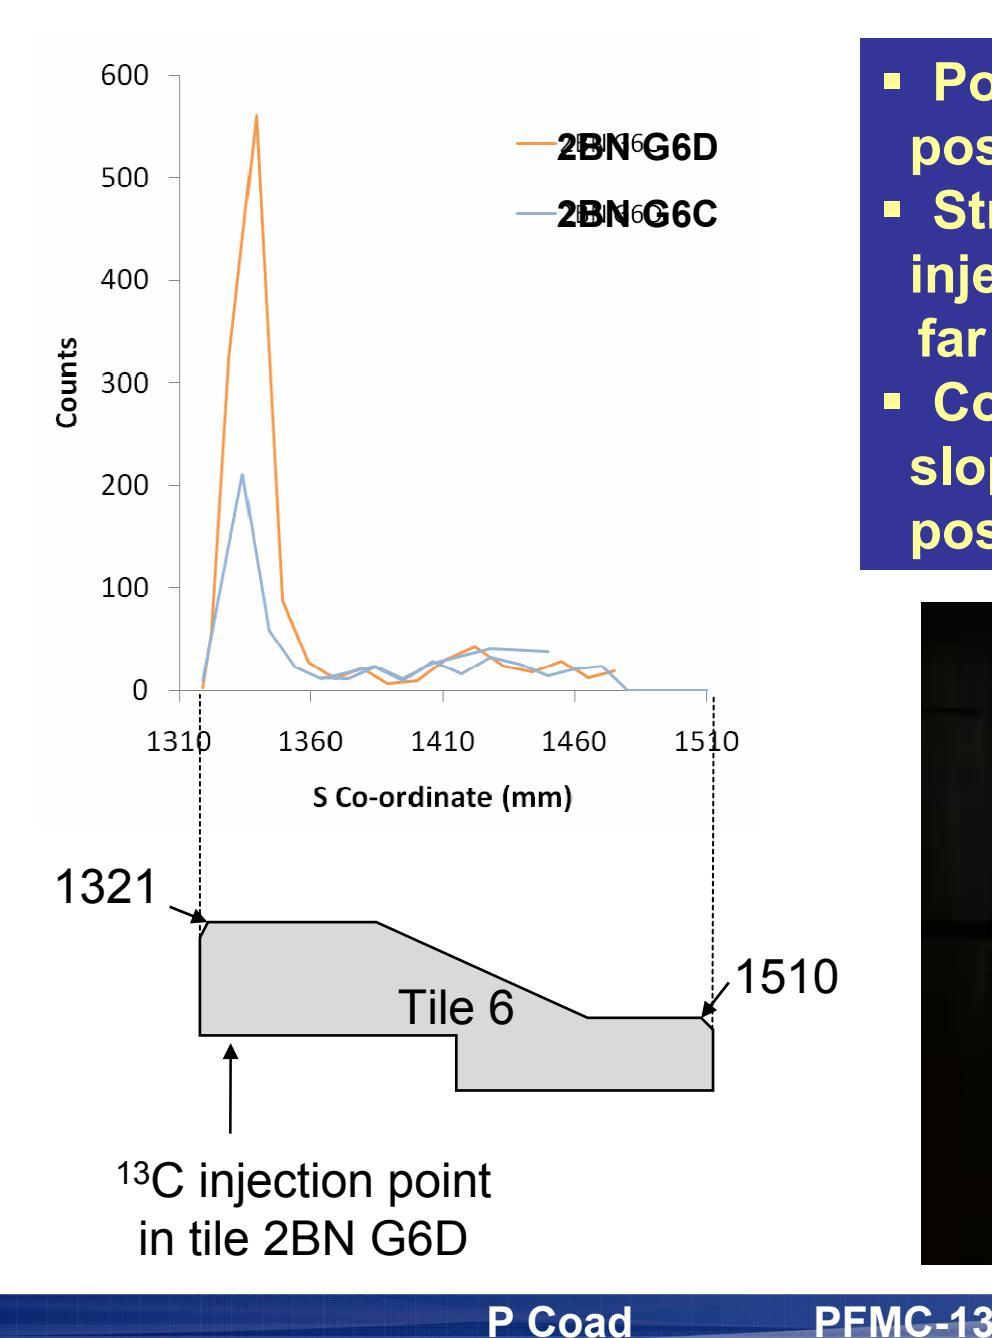
First profiles from RBS on tile 6 (SOL)

- Poloidal distribution at a toroidal position on two tile 6
- Strong local deposition close to injection location but also deposition far from the puffing hole
- Comparable deposition pattern in the sloping part of tile 6 at both toroidal positions (from re-eroded ¹³C)

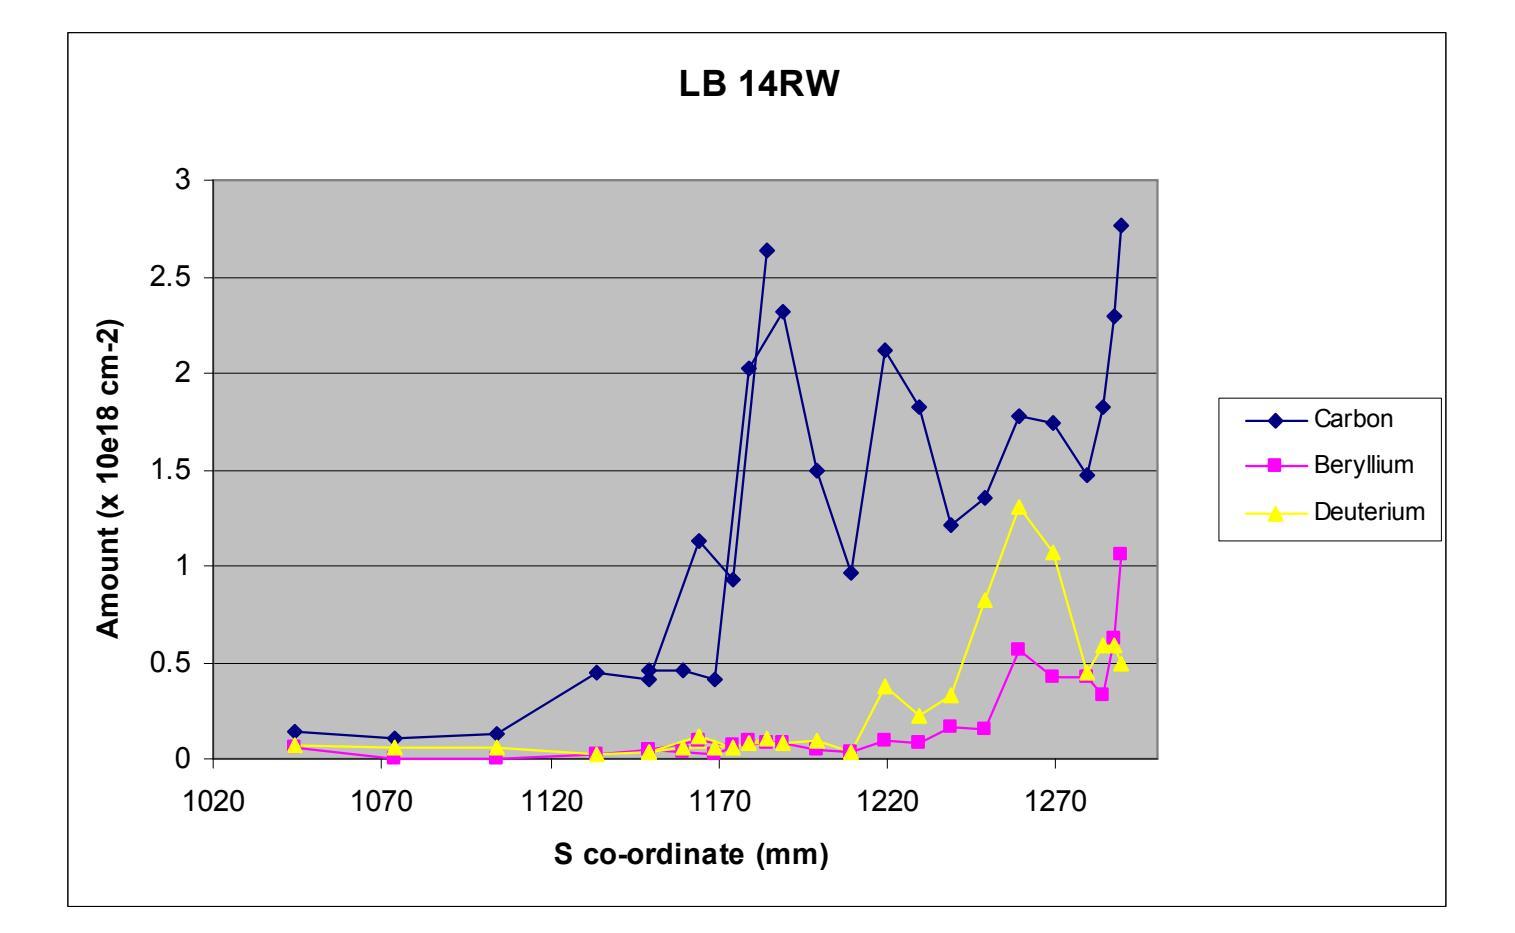
EFJET W coating on LB tile exposed 2007-9

2007-9 tile W coating is

still intact everywhere, and no thinning was measurable by IBA – in contrast to the situation on IWGL tile 3X11L

Peaks of ¹²C and ¹³C just inside PFR. Also ¹²C increases (and Be and D) towards outboard edge

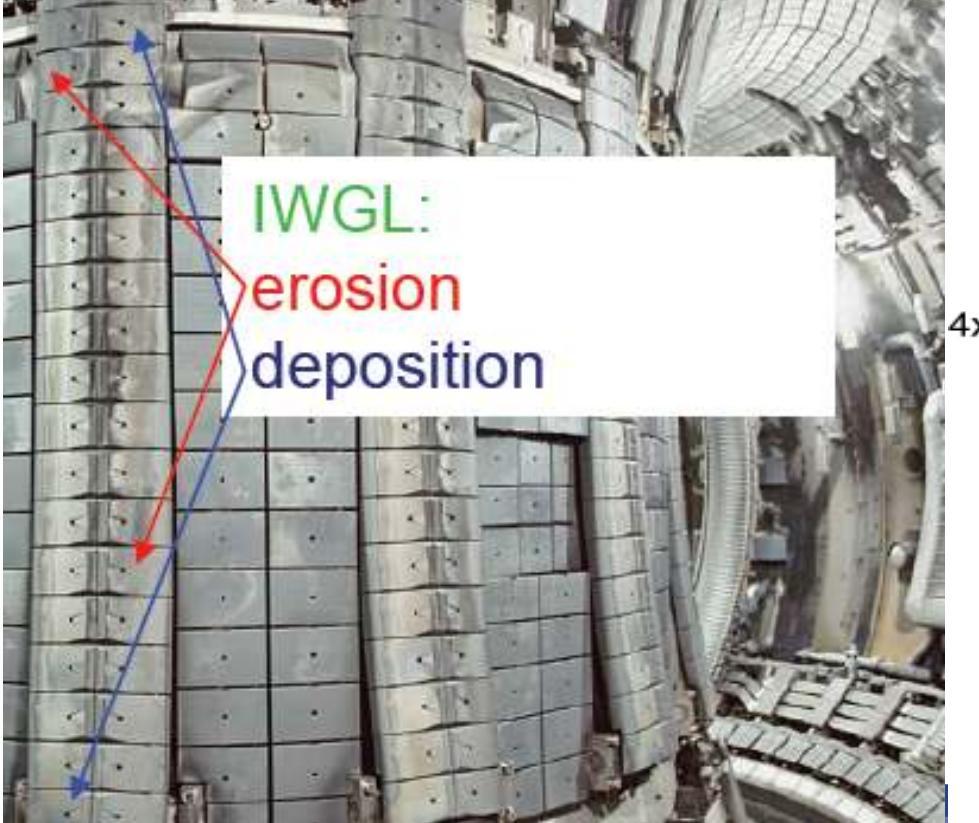
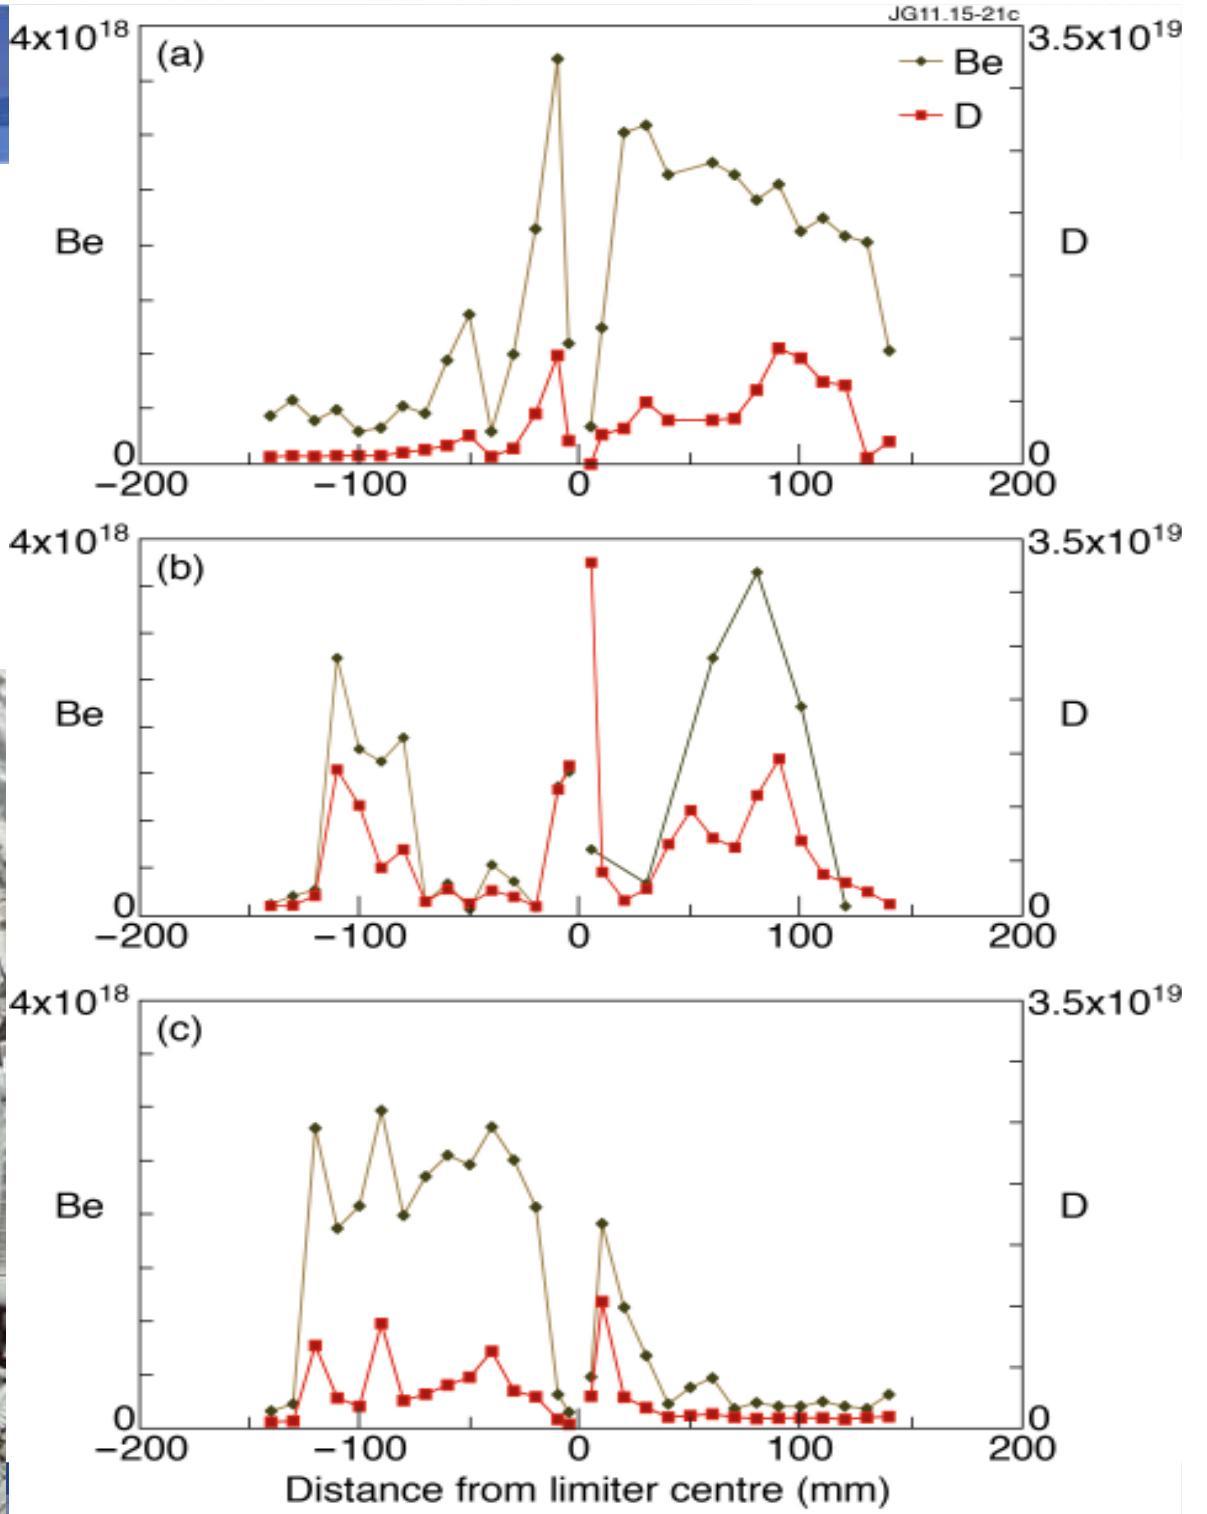
NRA data for Be and D on pairs of IWGL tiles at the top, middle and bottom of the limiter

³He energy beam (2.5 MeV) D(³He,p)⁴He, ⁹Be(³He,p)¹¹B,

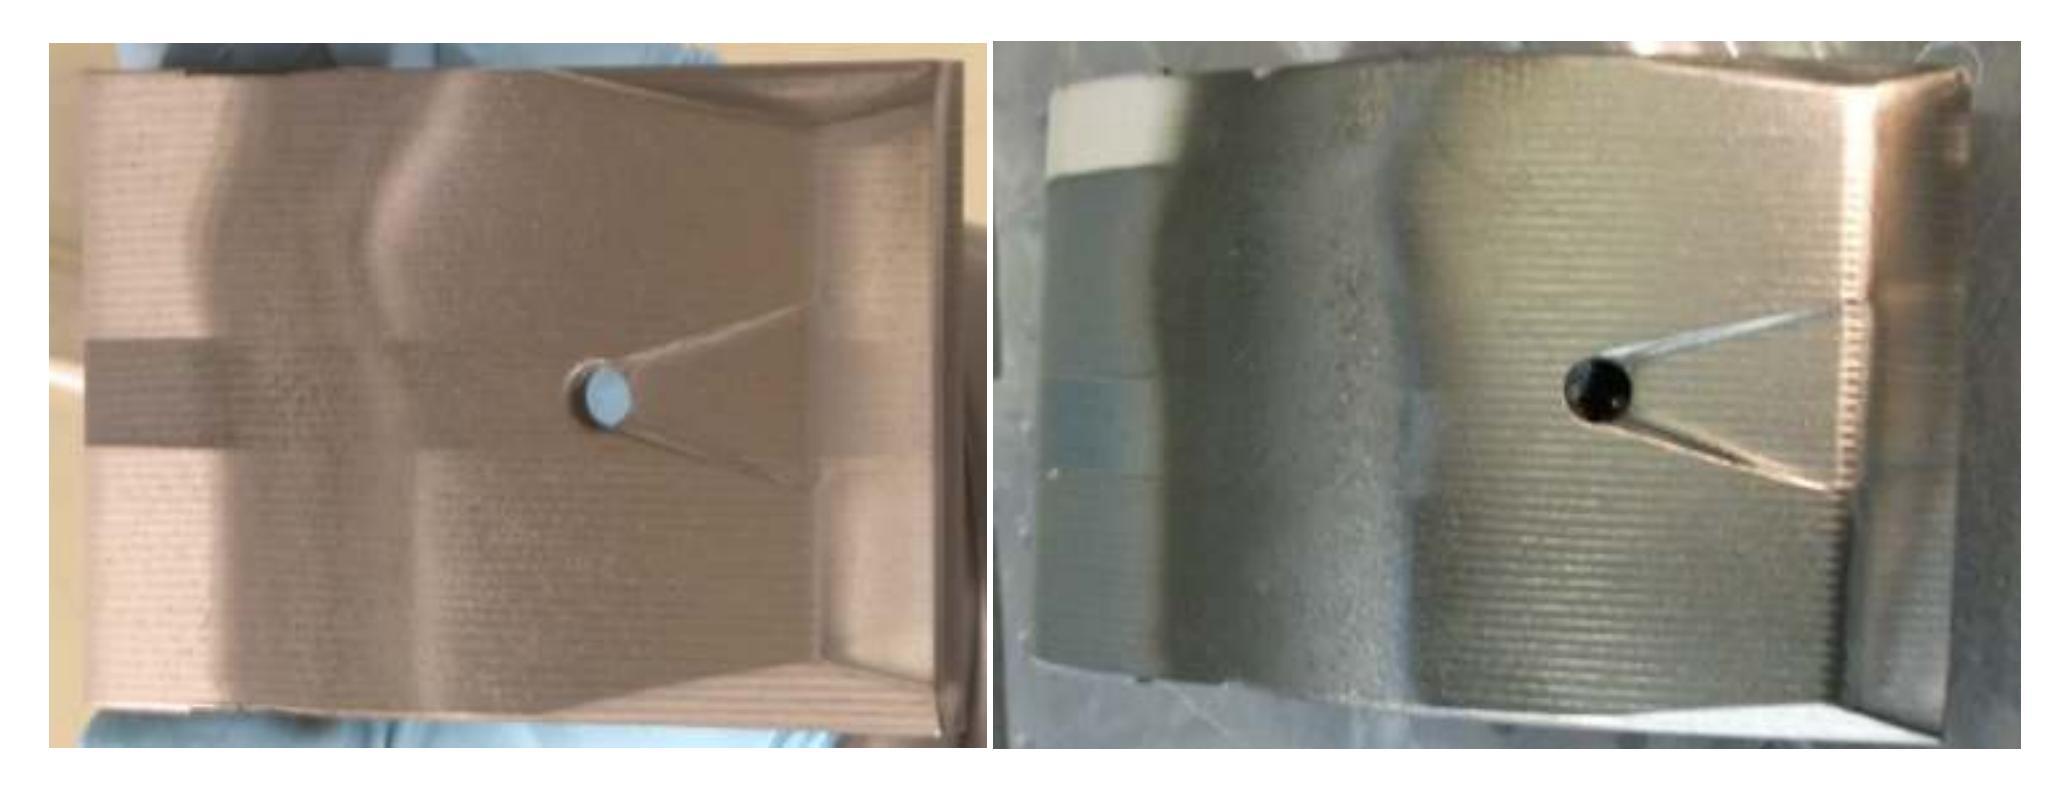
Erosion of IWGL tiles

7X12L exposed 2005-2007, coated with W and Re stripes

3X11L exposed 2005-2009, coated with W along top edge

Conclusion is that the erosion of the IWGL near the mid-plane is due to start-up plasmas and not neutral beam shine-through

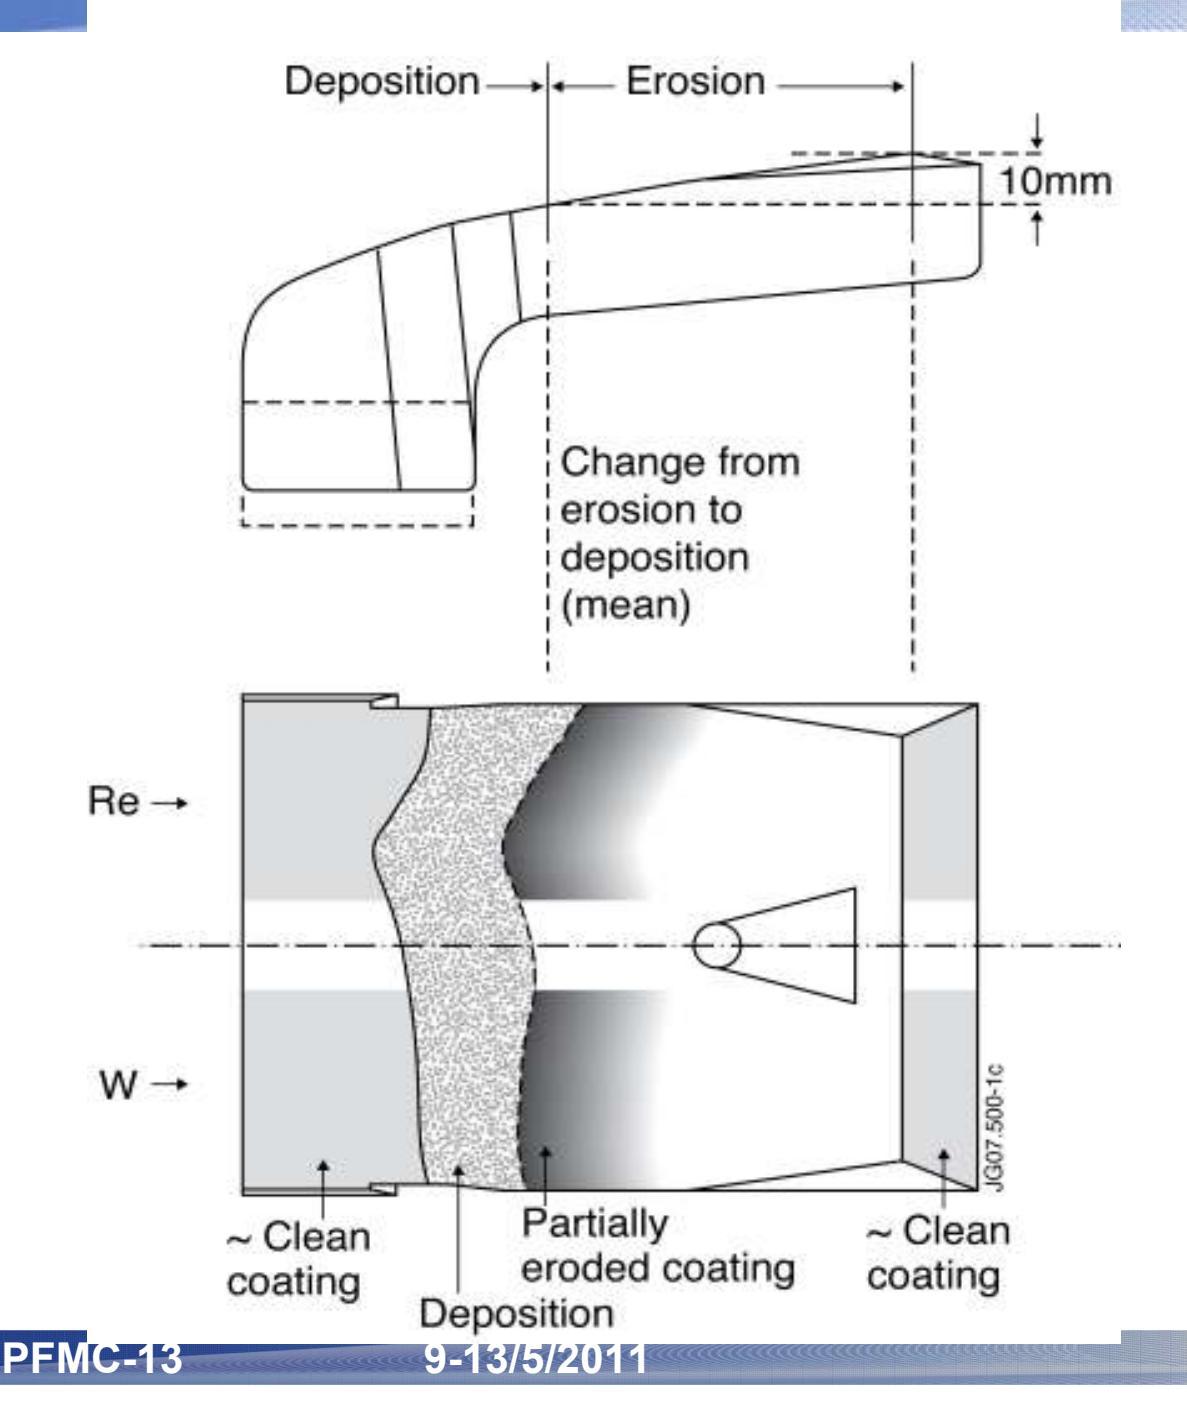
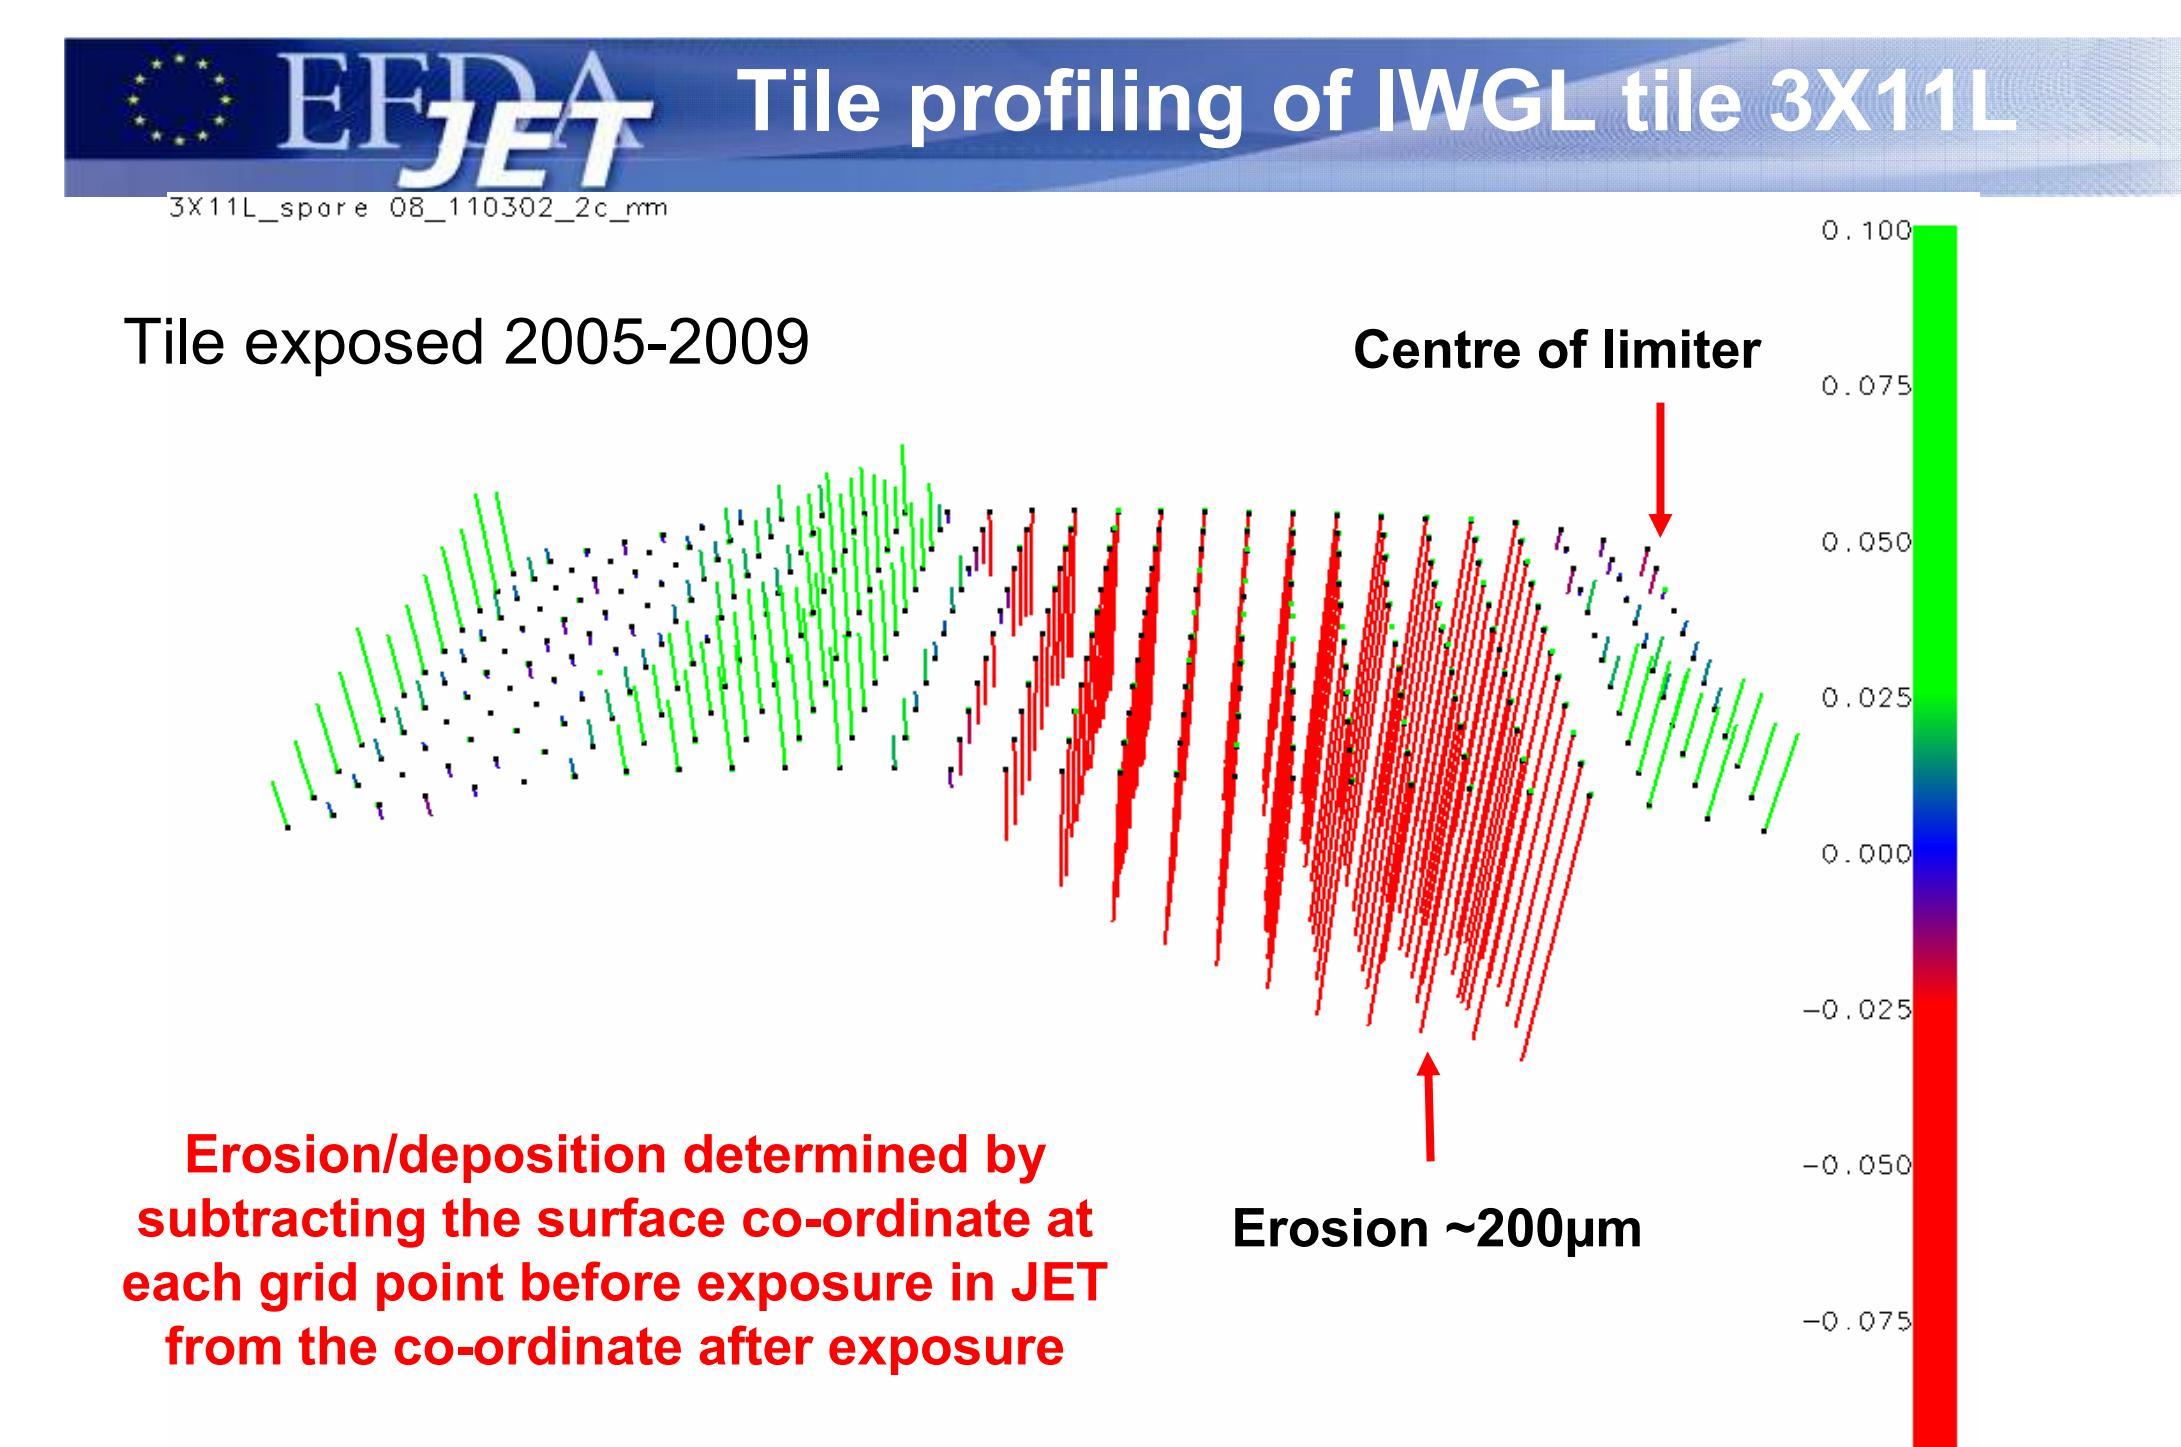
Schematic views of IWGL tile 7Z12L (middle of limiter) showing the erosion and deposition zones, and their positions relative to the leading edge of the tile. Tile 3X11L is similar.

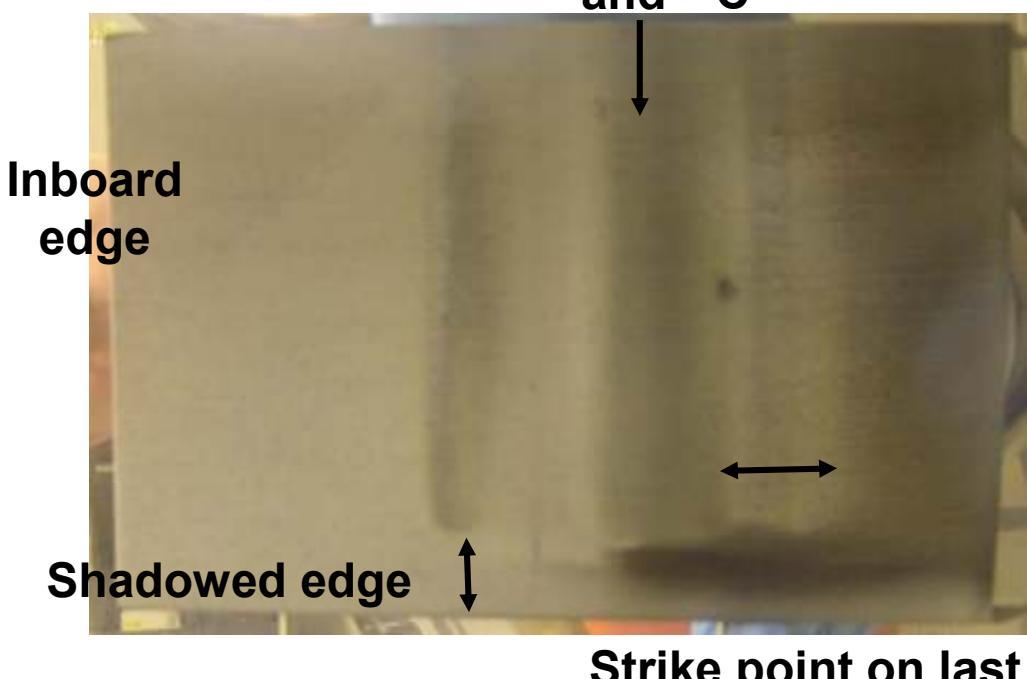
Experience with W-coated LB SRP tiles

LB SRP tile coated with ~10 µm W and exposed in JET 2007-2009

Maximum ¹²C and ¹³C

Strike point on last day of operations in 2009?
