Overview of JET post-mortem results following the 2007-9 operational period, and comparisons with previous campaigns

Plasma facing Components: Erosion/Deposition (Global trends)

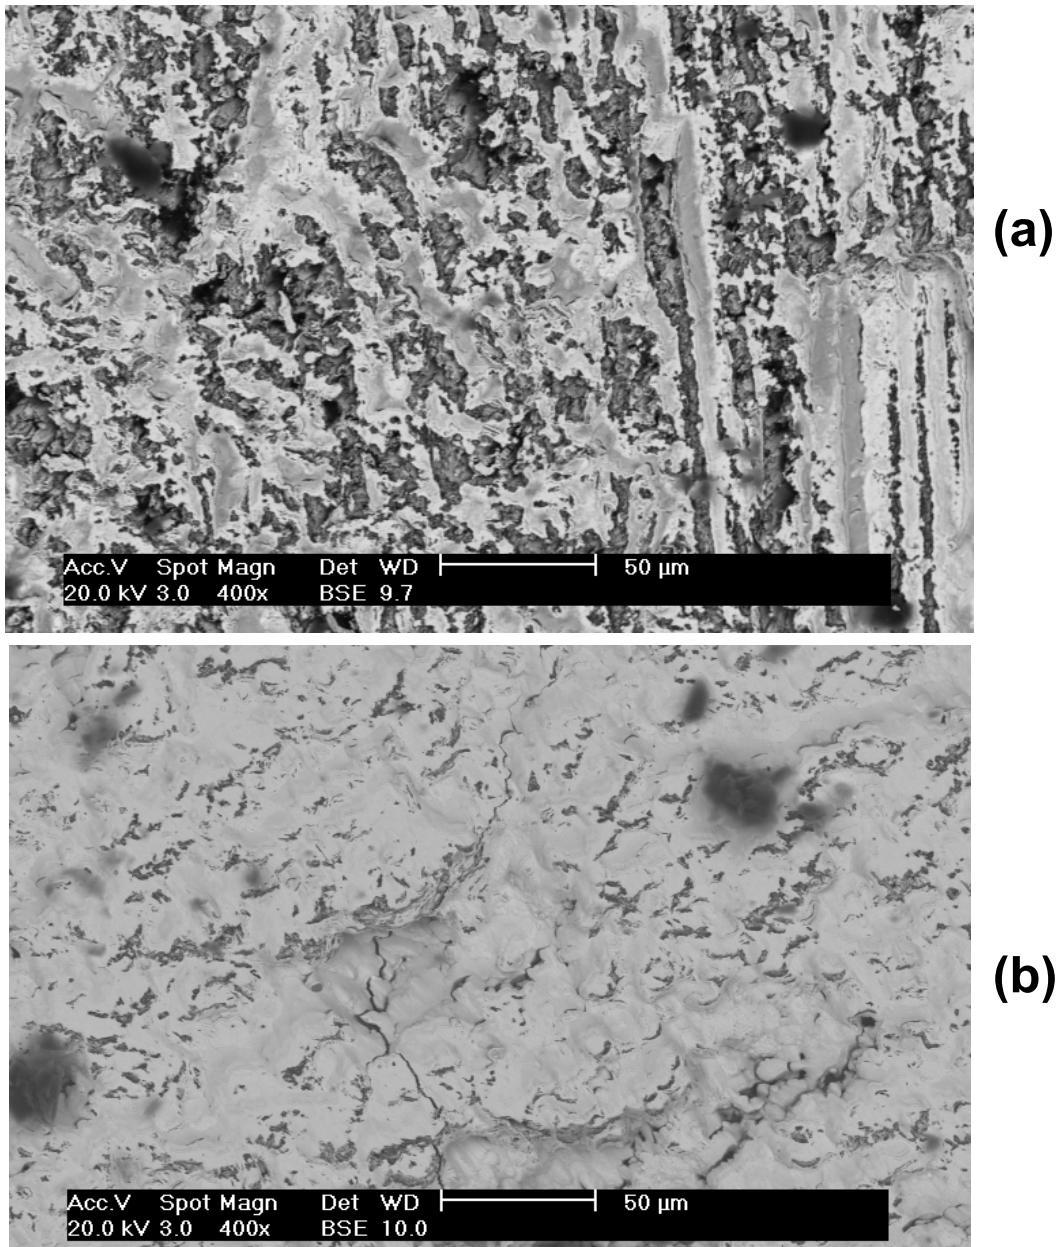
EFJET W coatings on LB tile exposed 2005-7

LB SRP tile coated with ~0.7 and 1.6 µm stripes W and exposed in JET 2005-2007

Thinner W coating (0.7µm) has been eroded from plasma-facing areas and redeposited in areas shadowed by the roughness of the surface

Thicker coating (1.6 µm) is still covering all areas of the surface, though it is very thin at some points.
